BUILDING INSPECTION REPORT

69 Bosquesillo Road
Santa Fe, NM 87508

Inspection Date: 3/16/15

Report Number: 10039

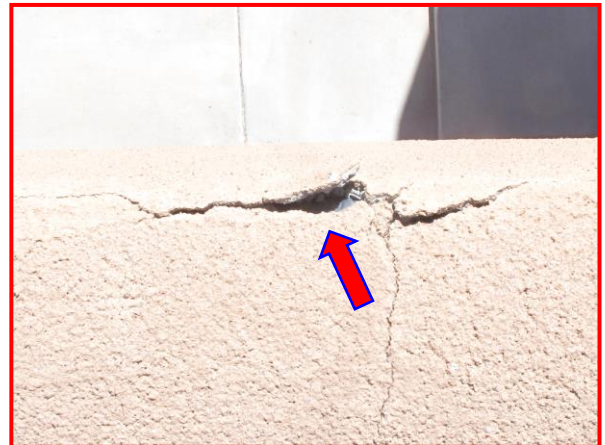
- Only one blister was found on the parapet at the front wall and needs to be patched and color to match the stucco color, or possible use the same product. Call the original contractor.

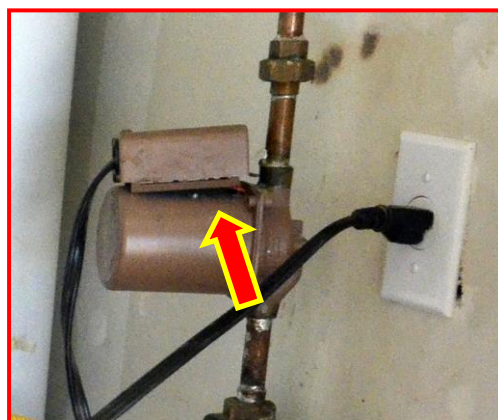
1. Consult with a Mechanical contractor or plumber to repair the TACO pump's cover plate.
2. Verify if TACO pump is working properly because it was not plugged in at the time of the inspection.
