BUILDING INSPECTION REPORT

3100 Monte Sereno Drive
Santa Fe, NM 87506

Inspection Date: 2/10/2020

Report Number: **10743**

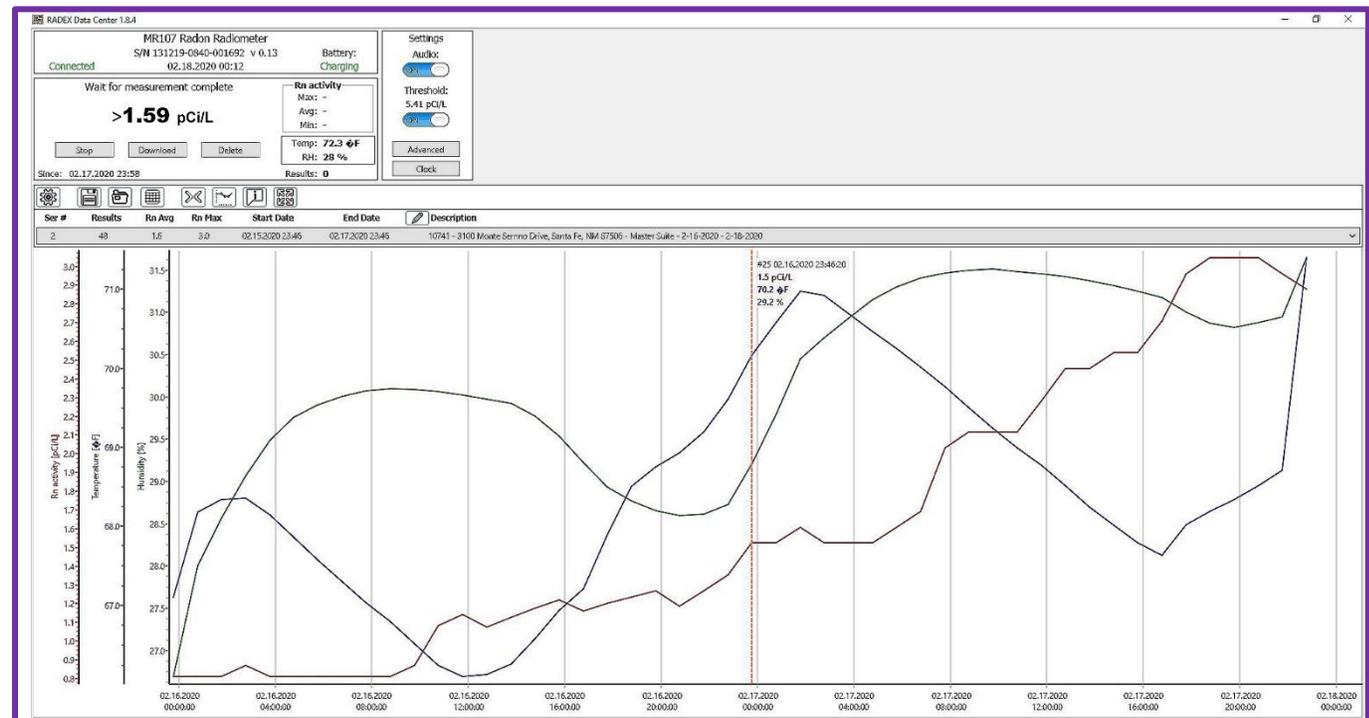
SECOND RADEX MR-107 Chart Reading 48-hour duration with Close House Conditions reading on Master Suite taken on 2/16-18/2020:

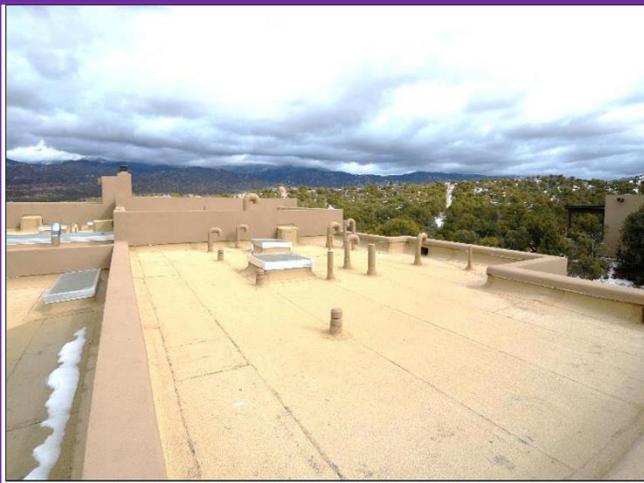
1. Torch-down roof membrane was professional installed, and maintenance should occur every 3-years and roof is in **Satisfactory Condition**,

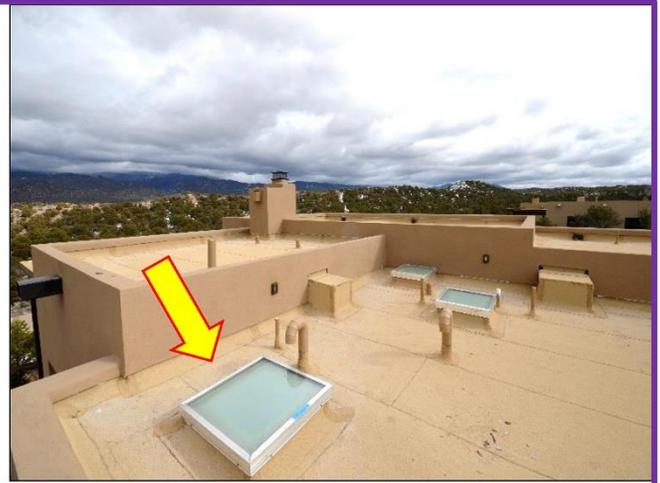
2. Torch-down roof membrane was professional installed surrounded by Parapets and **Velux** Skylights are in **Satisfactory Condition**.

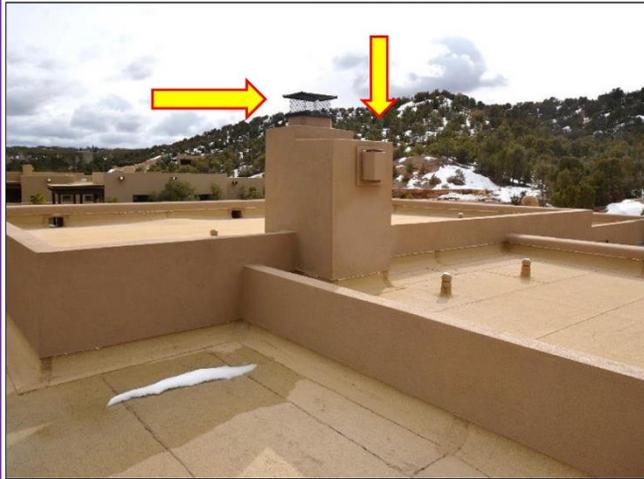
3. Chimney present with clay flue, spark arrestor and rain cap with a second gasfired exhaust jacket are in **Satisfactory Condition**.

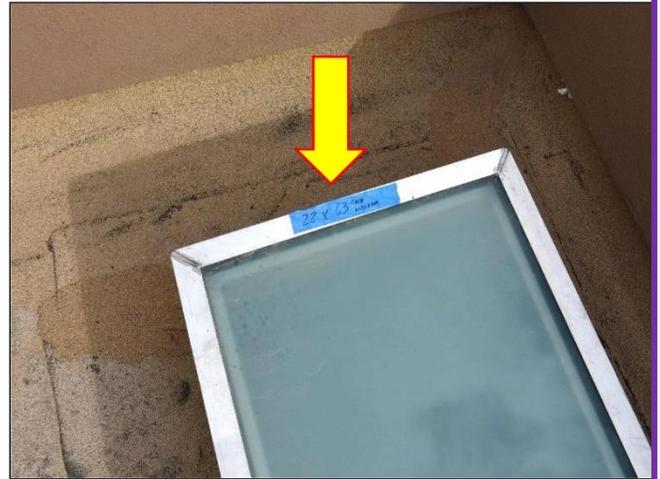
4. Tape found on the **Velux** Skylights should be removed.

6. **Repair:** Tape should be removed from **Velux** Skylights.
7. **Repair:** Tempered glass panel on Bathroom #2 Should be moved so that the faucet can be accessed.

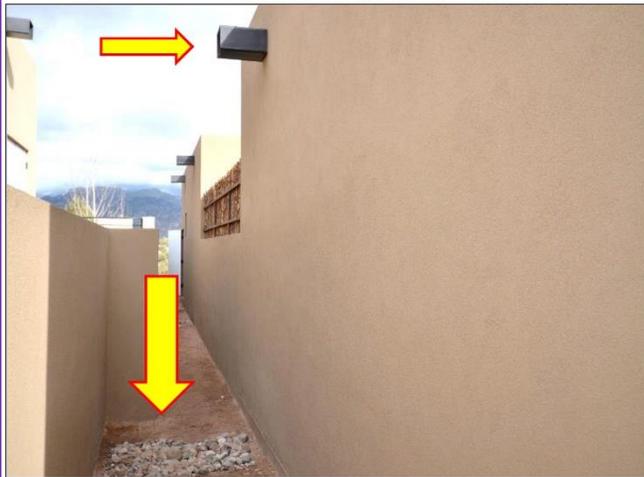
5. Northside Alley between properties is surfaced with crushed gravel and the 10x12 open steel canales above drained to large river rock stones.

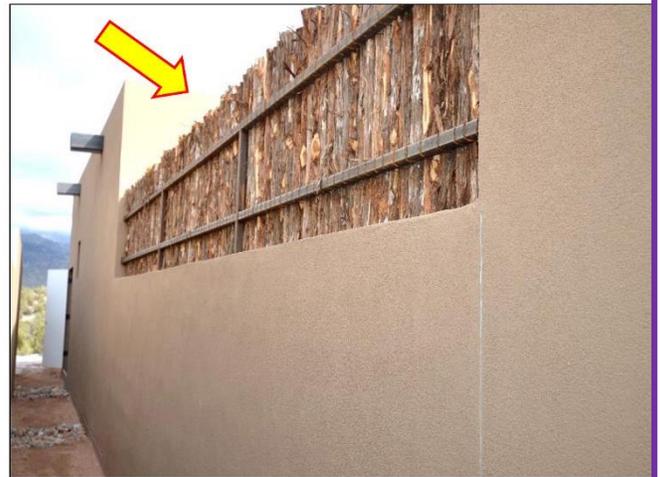
6. Backside of the Coyote fencing found above the wall to the Patio Entrance is in **Satisfactory Condition**.

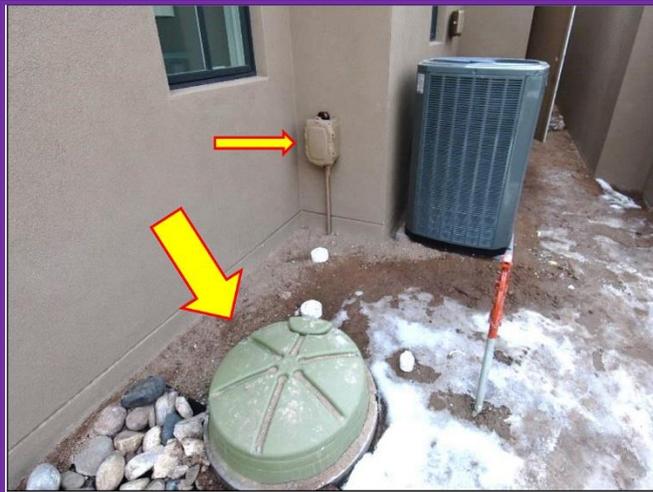
7. Waste Lift Station with alarm was found on Northside of the property and will need professional inspections at the required time as per the State.

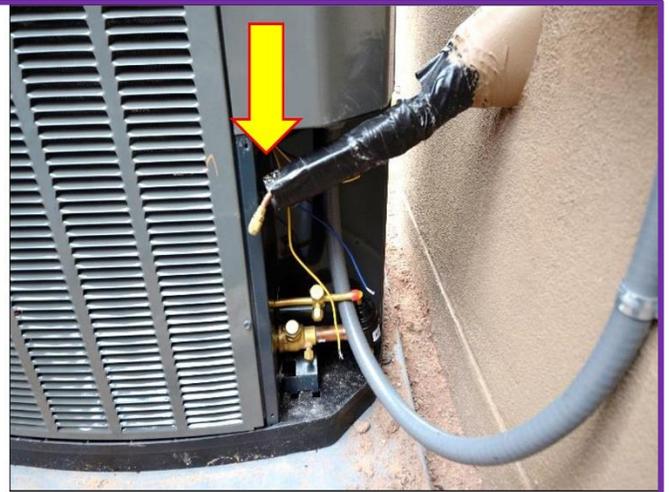
8. Outdoor **Trane** Condenser has not been completely hooked-up with the refrigerated pipes.

2. **Repair:** The AC refrigeration pipes, and the electrical connections were not completely installed.
3. **Repair:** Mechanical AC/ Furnace Room with outside access; doorknobs & hardware will need to be provided.

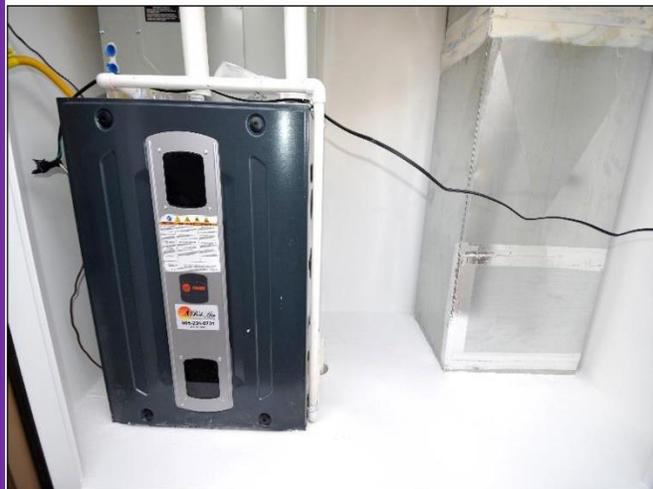
9. Northside Mechanical Closet with **Trane** Furnace and AC Unit was professional installed and is in **Satisfactory Condition**, except for, see picture #10.

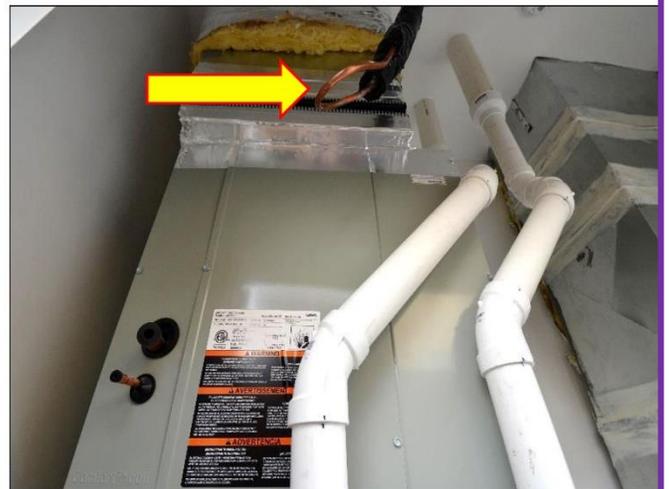
23. **SPECIAL NOTICE:** The **Trane** Furnace/ AC mechanical equipment installation was not completed and therefore, the Buyer should insist that it's fully operationally and tested before taking possession.

10. **Trane** Furnace and AC Unit has not been completely hooked-up with the refrigerated pipes.

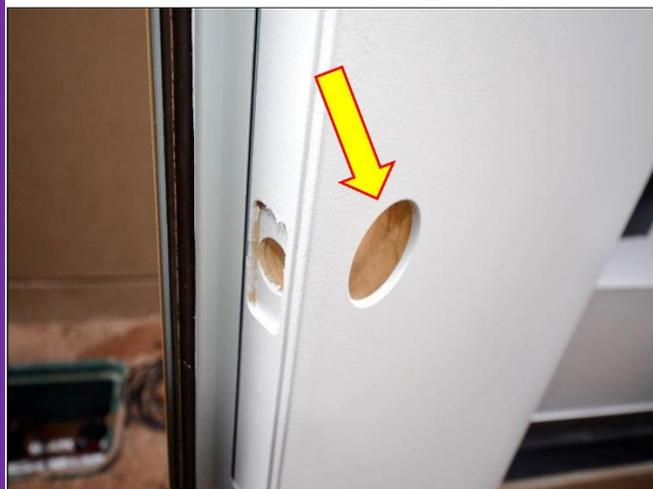
11. Northside Mechanical Closet doors are missing their doorknobs.

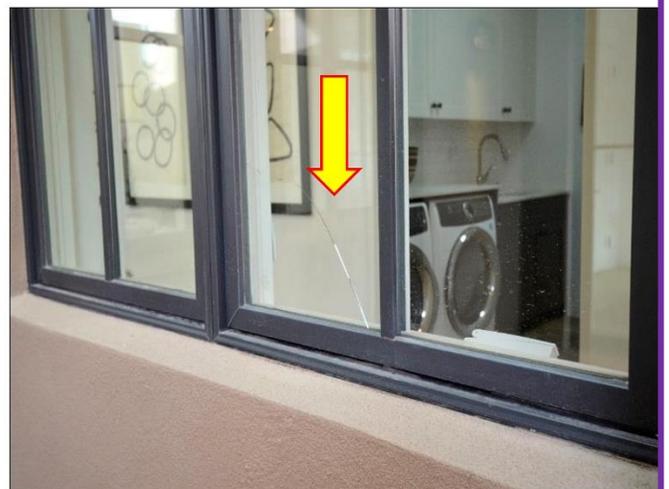
12. Crack found on one of two Pella windows will need to be replaced.

4. **Repair:** Cracks were found on two, (2) **Pella** windowpanes that will need to be replaced.
5. **Repair:** Recess light fixtures under the Garage soffit will need better stucco detailing.

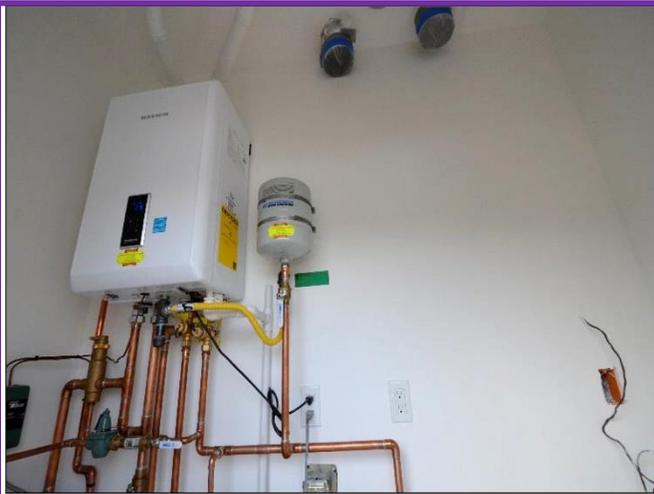
13. Southside Mechanical Closet for the **Navien** Boiler & Domestic H₂O, was professional installed and is in **Satisfactory Condition**,

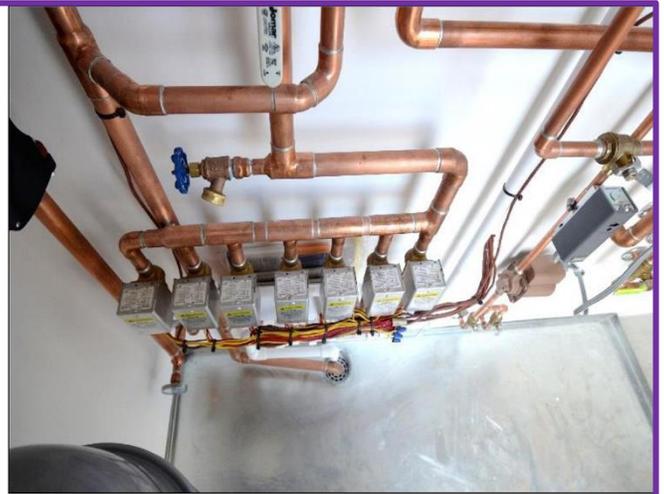
14. Southside Mechanical Closet with 7-Zones' for radiant heating was professional installed and is in **Satisfactory Condition**,

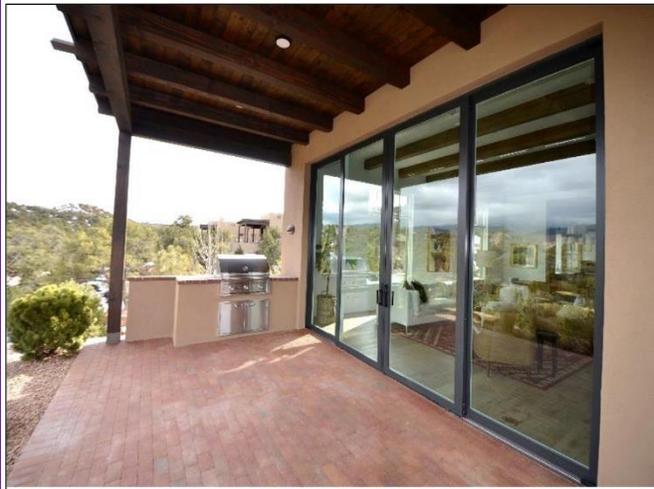
15. East Side View Patio with Portal & posts, Bar-B-Que and tempered sliding glass doors to the Great Room are in **Satisfactory Condition**,

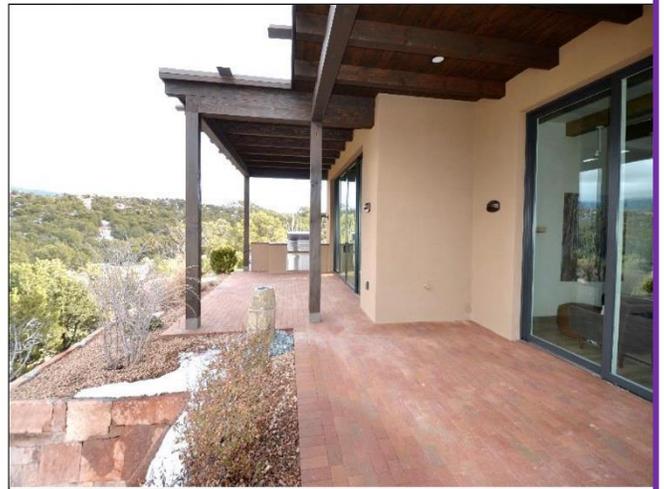
16. East Side View and connecting Patios for Master Suite and the Great Room with brick walkways and overhead Portals are in **Satisfactory Condition**,

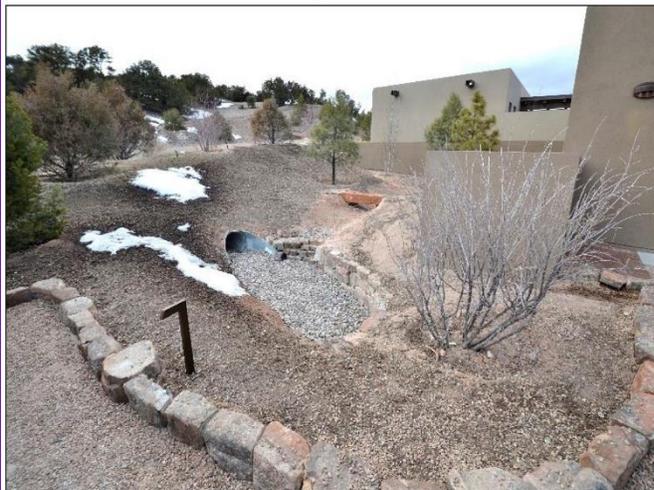
17. West end of property at the Entrance is properly landscaped with a drainage culvert to bypass the water run-off is in **Satisfactory Condition**,

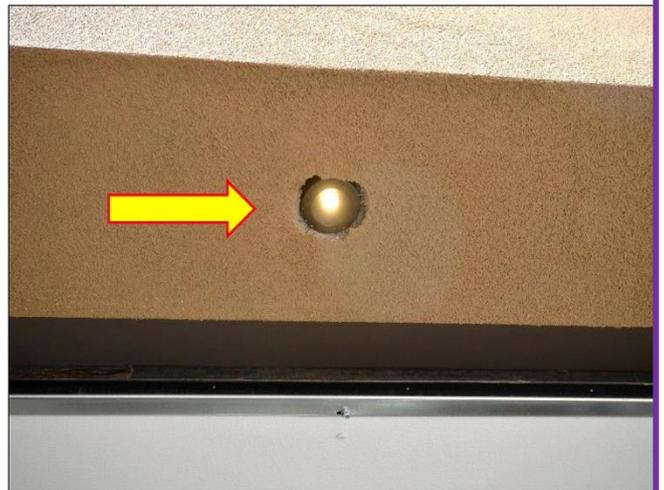
18. Two Recess light fixtures under the soffit will need better stucco detailing around the trim.

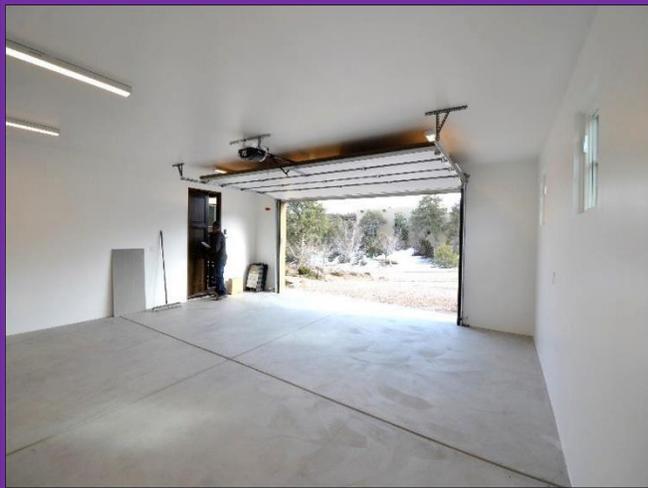
19. Garage with concrete floors and fully painted 5/8" drywall as per code and automatic overhead garage door are in **Satisfactory Condition**,

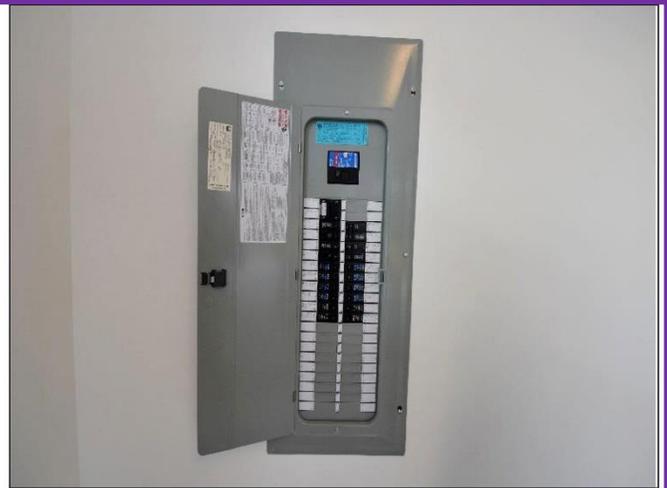
20. Primary **200Amp** electrical Panel inside the Garage is properly labeled and is in **Satisfactory Condition**,

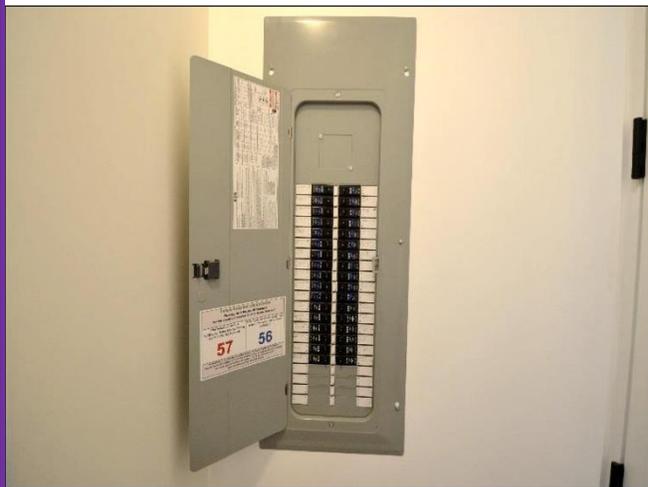
21. 2nd **200Amp** electrical Subpanel inside the Laundry Room is in **Satisfactory Condition**,

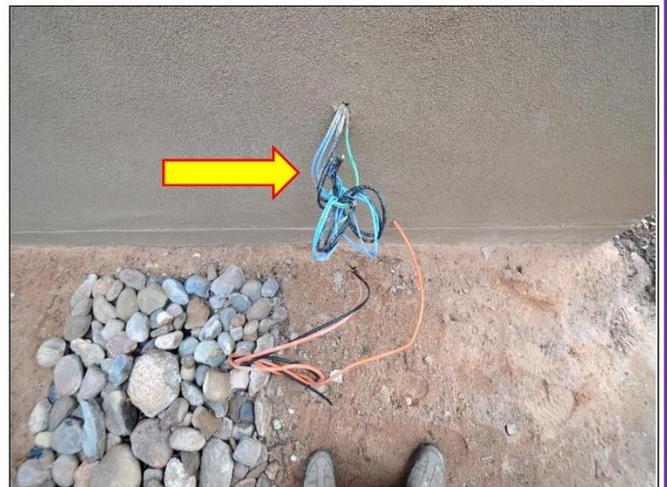
22. Messy Low Voltage wiring should be terminated into an enclosure.

8. **Repair:** Messy low voltage wiring on the North wall should be terminated inside an enclosure.
9. **Repair:** Low voltage thermostat wire found in Bedroom one closet that was not terminated.

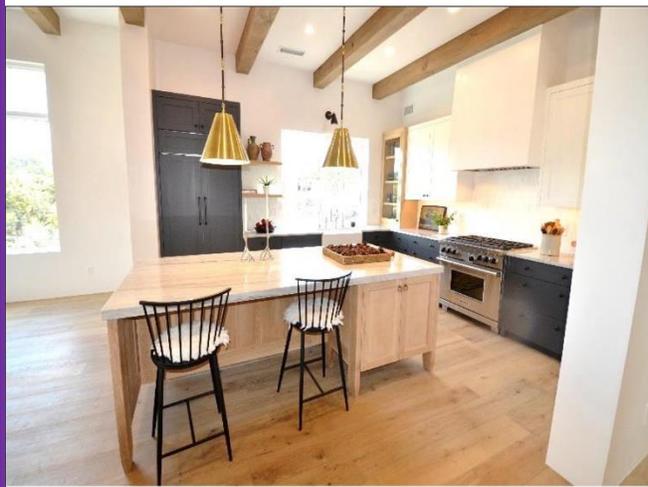
23. Kitchen is in **Satisfactory Condition**,

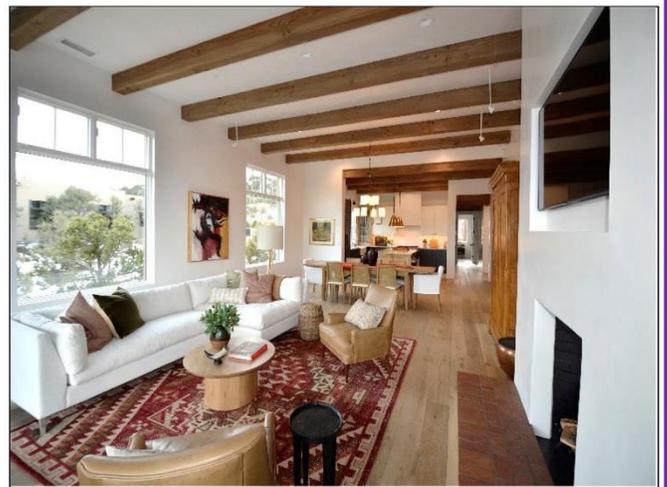
24. Great Room with Living Room and wood burning fireplace are in **Satisfactory Condition**,

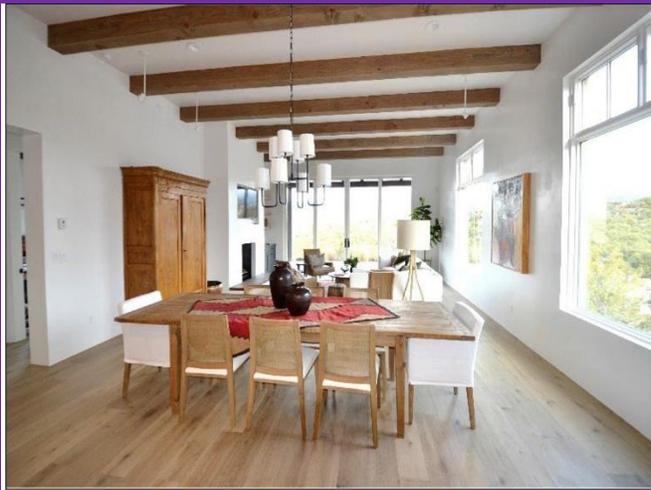
25. Dining Room is in **Satisfactory Condition**,

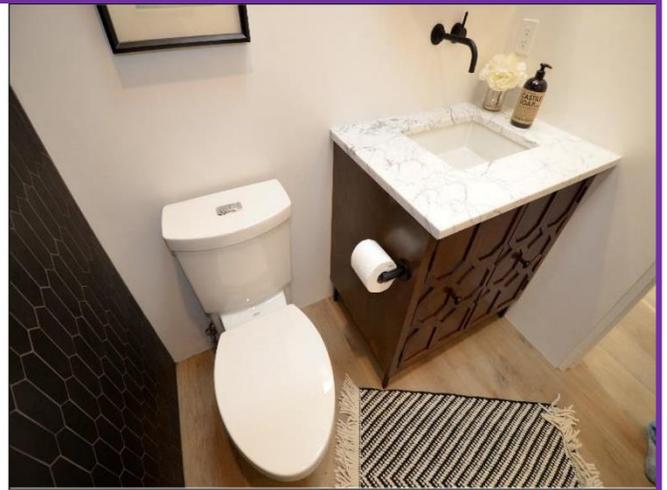
26. Powder Room Bathroom with single **Kohler** sink and vanity and **American Standard** toilet are in **Satisfactory Condition**,

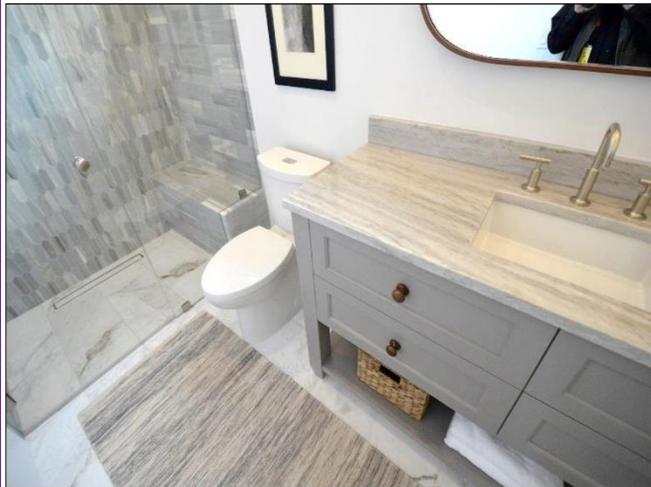
27. Hallway Bathroom for either of the two Bedrooms has an enclosed walk-in shower. **American Standard** toilet and single vanity is in **Satisfactory Condition**.

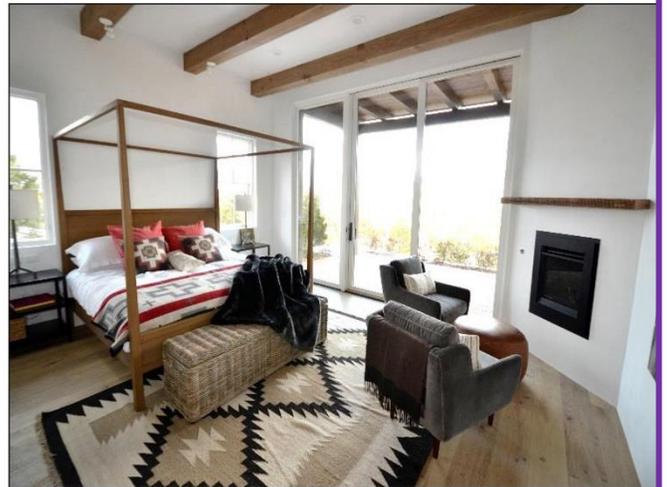
28. Master Suite Bedroom with access to Patio with Pella tempered sliding doors and gas fireplace with missing controls is in **Satisfactory Condition**,

10. **Repair:** Could not find the Remote to the gasfired Kiva fireplace in the Master Suite.
11. **Repair:** There was no apparent Freeze Protection found inside the Mechanical Closets?

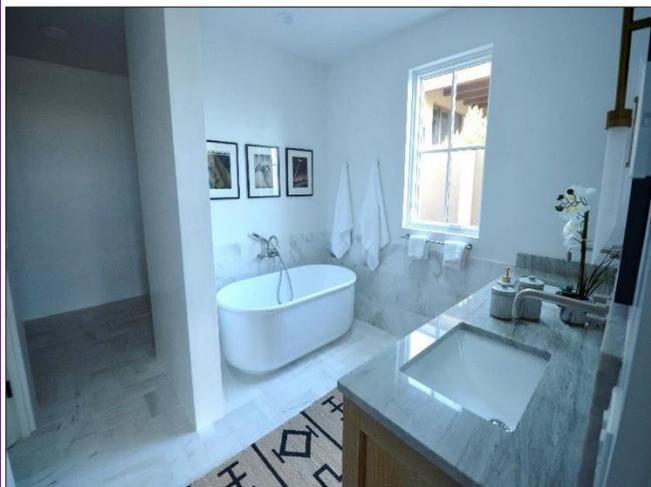
29. Master Suite Bathroom with enclosed shower, double vanity **Kraus** sinks and **Kohler** poly free-standing bathtub are in **Satisfactory Condition**.

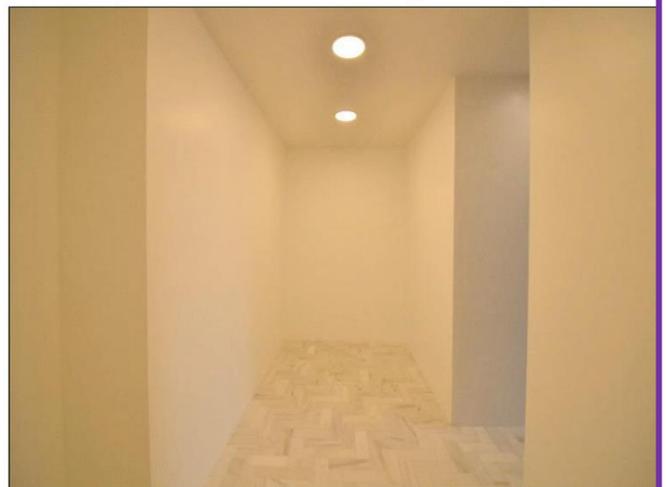
30. Master Suite Walk-in Closet is in **Satisfactory Condition** and is a blank slate without shelving and storage will need to be designed by the new owners.

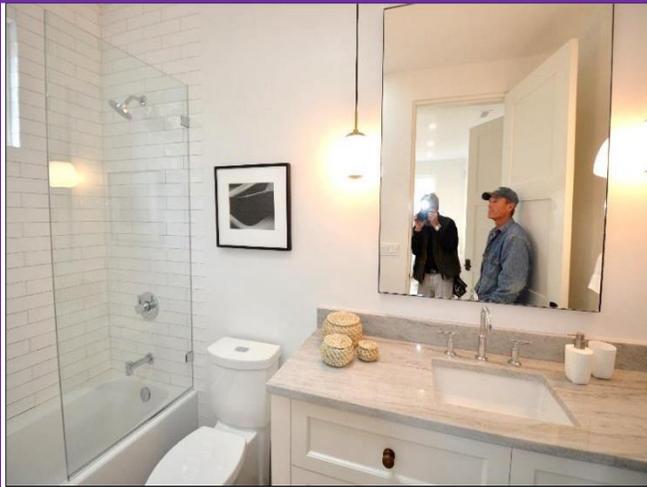
31. Bathroom associated with Bedroom #1 is in **Satisfactory Condition**, with exception that the tempered glass panel for the Bathtub is backwards.

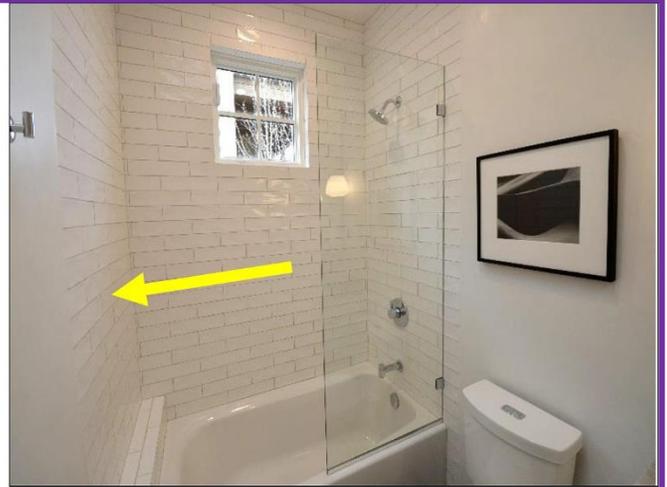
32. Tempered glass panel for the Bathtub is backwards and should be installed at the other end to properly access the faucet as per UBC & State CID Codes.

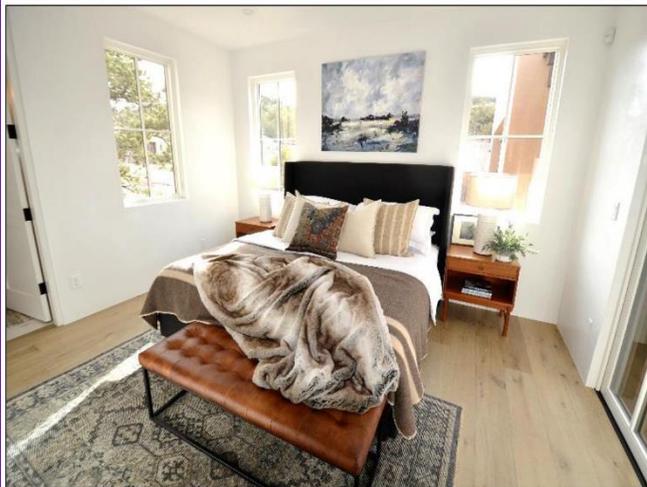
33. Bedroom #1 of #2 with wood floors is in **Satisfactory Condition**.

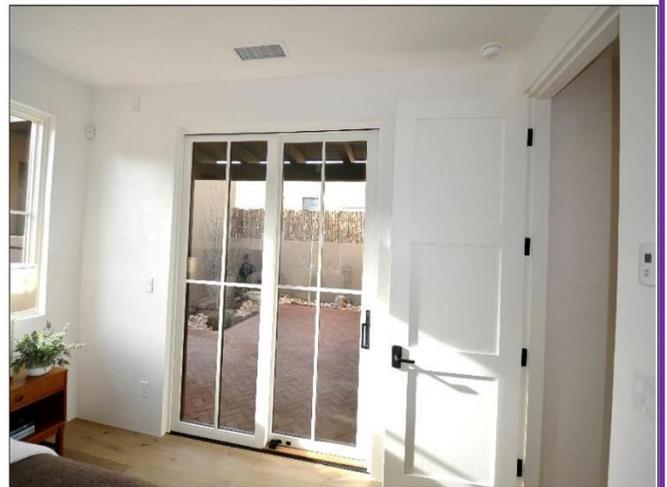
34. Bedroom #2 with tempered sliding Patio doors is in **Satisfactory Condition**.

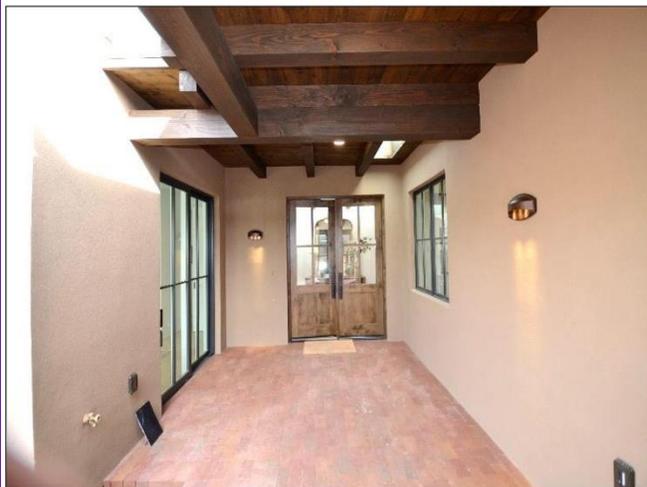
35. Entrance to House under cantilever Portal with brick over concrete slabs is in **Satisfactory Condition**.

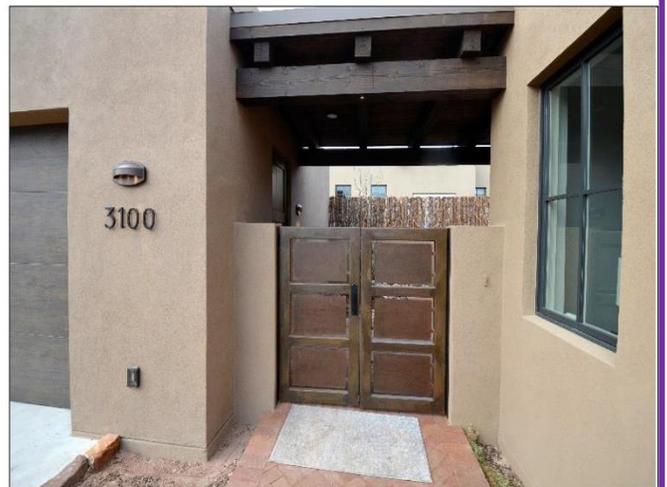
36. Entry gates to the House is in **Satisfactory Condition**.

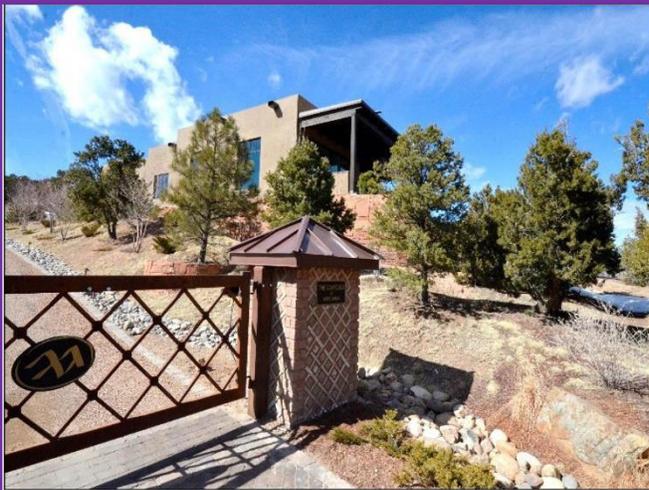
37. Project has an Automatic and Secure Entrance Gate & Monuments over an Asphalt driveway.

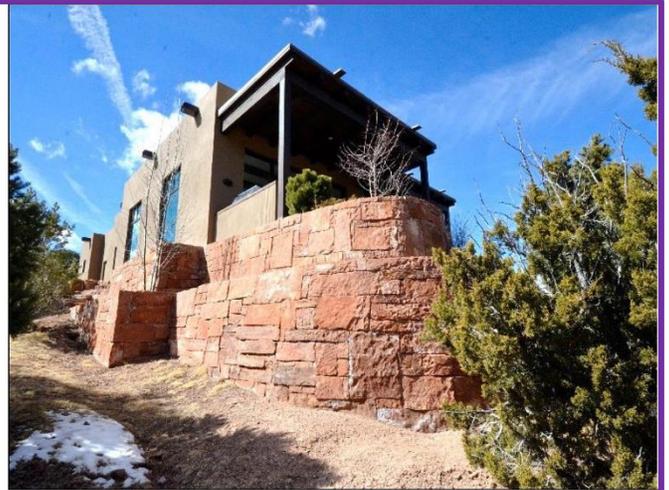
38. Proud upper Southeast view of the House perched on massive rock retaining walls.

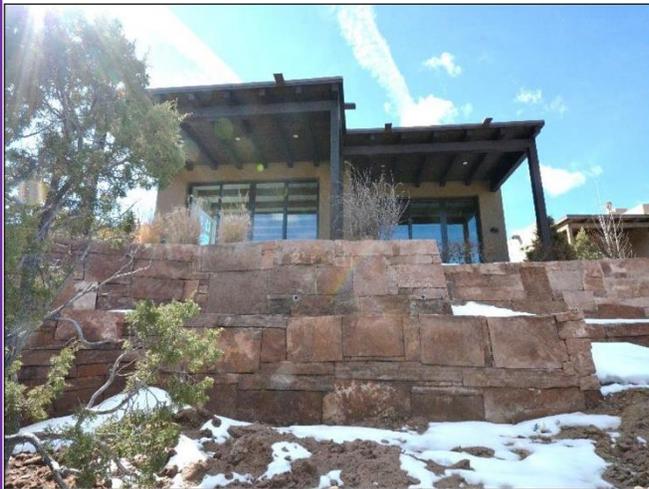
39. Eastside view of House perched on massive retaining rock walls that are stepped-back with terraces and weep drainage

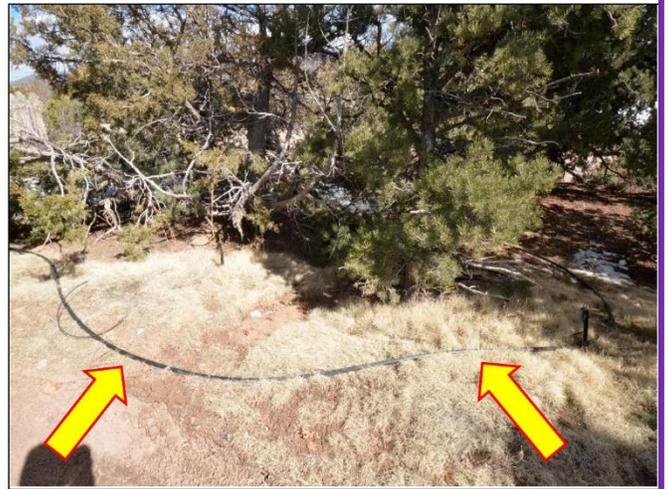
40. Property has built-in drip irrigation piping throughout for watering the gardens with many alpine trees and natural shrubs.

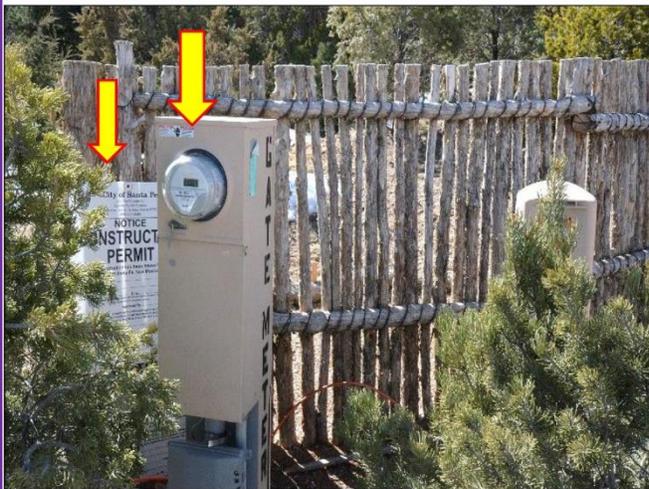
41. PNM Meter pedestal at the street and sewer covers were on the asphalt pavement. Building Permit placard found in the background.

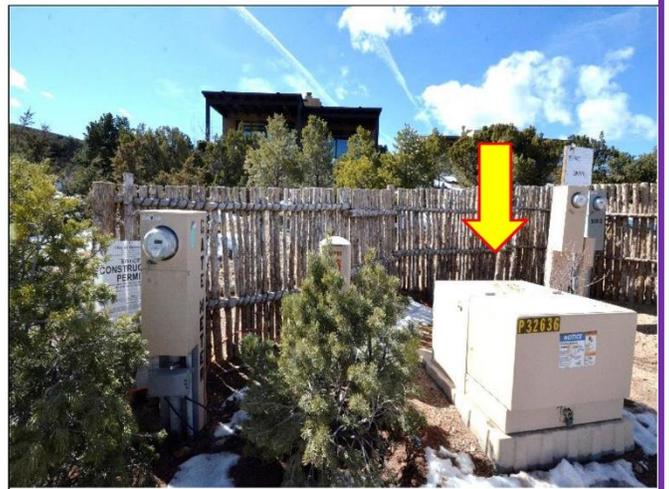
42. Long East view of Street Frontage with all utilities and adjoining property with PNM transformer, cable and telephone. Gas meter in at the building.
