BUILDING INSPECTION REPORT

1207 Sixth Street
Las Vegas, NM 87701

Inspection Date: 2/16/19

Report Number: **10543**

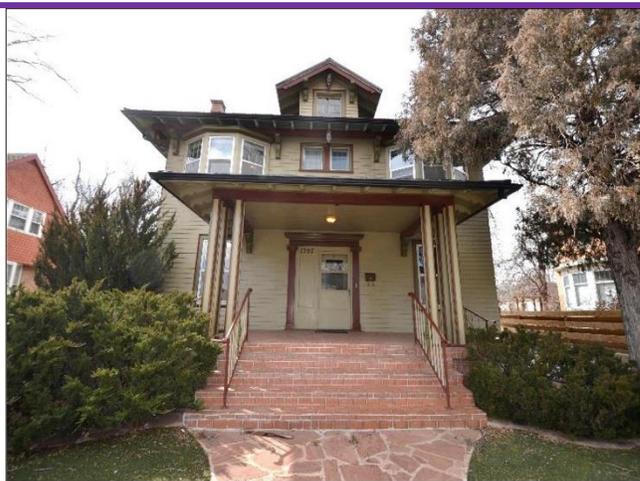
1. Entrance of House has a synthetic lawn on both side of the flagstone walkway. And, there was a recent "black" Propanel roof installed.

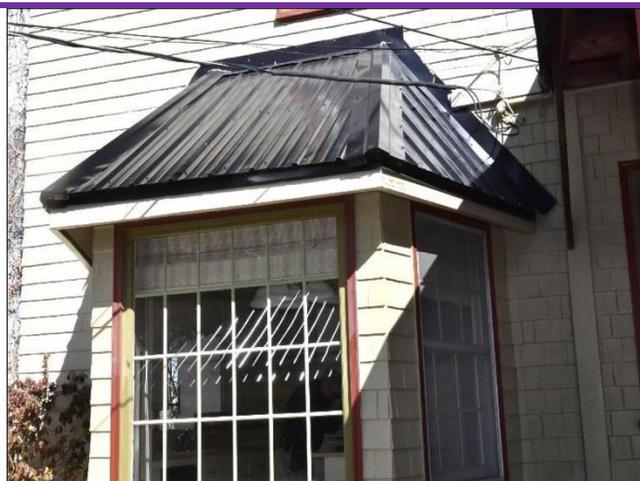
2. All roofs and overhangs, dormers, Garage and Auxiliary Building have had recent metal "black" Propanel roof systems installed very well.

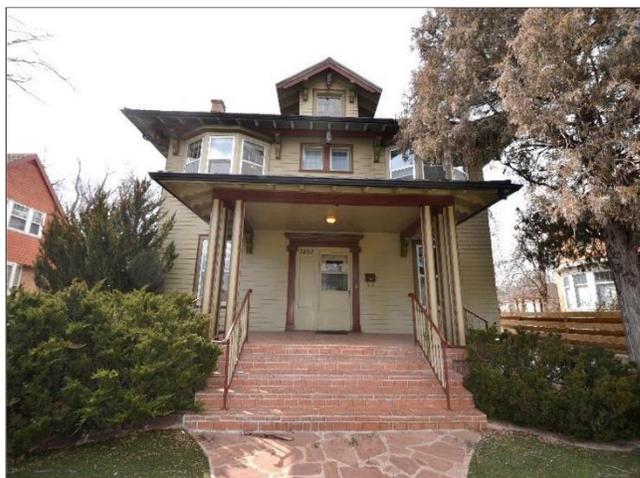
3. Entrance of 2-story Victorian House with Dormer window and bow-windows are in Satisfactory Condition.

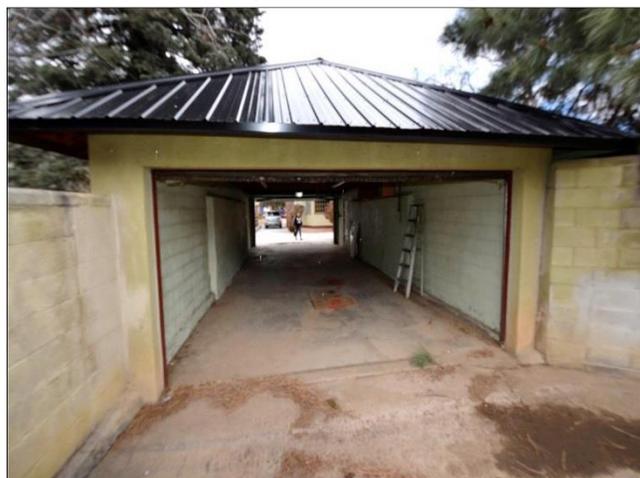
4. Two-car tandem garage opens to entrance driveway and the alley are in Satisfactory Condition.

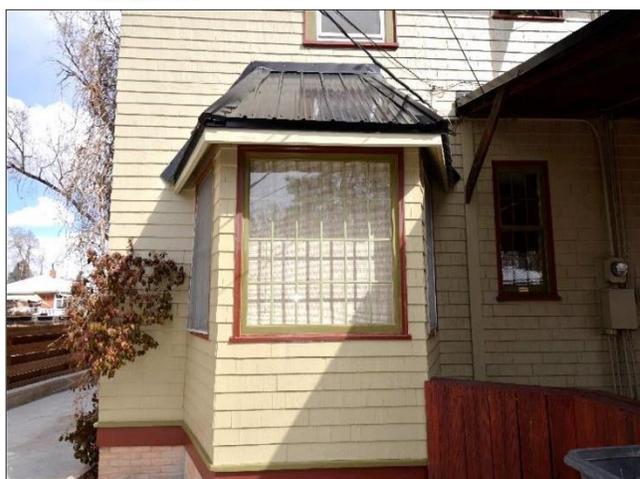
5. Typical example of the "black" Propanel roof systems installed on building "pop-out" room are in Satisfactory Condition.

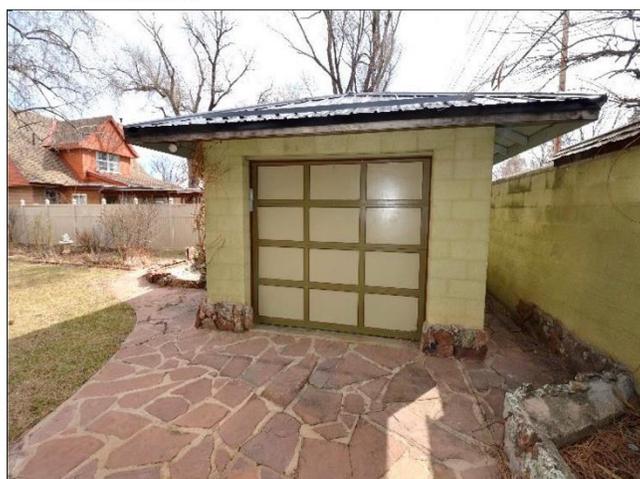
6. Auxiliary Building made of CMU block walls is Auxiliary Building. Flagstone needs some masonry attention.

13. A Mason is needed to repair and replace flagstone on the patios.

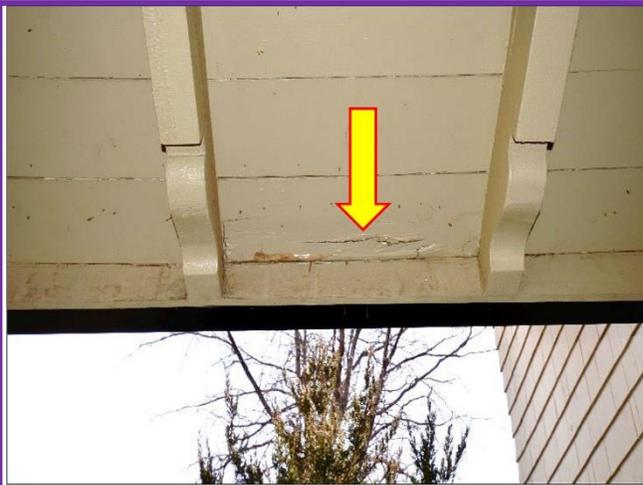
In the Future, probably within one-year, this dwelling will need all exterior wood shingles and trim to be maintained and painted as needed. Some rot was observed on this Report under the eaves at the front and rear porches.

7. Some "rot" found under eaves at the Entrance porch needs to be cut out, patched and painted.

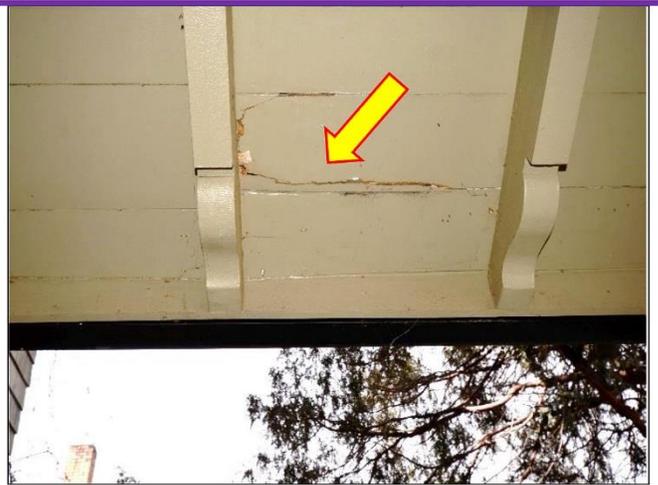
8. More "rot" found under eaves at the backyard porch needs to be cut out, patched and painted.

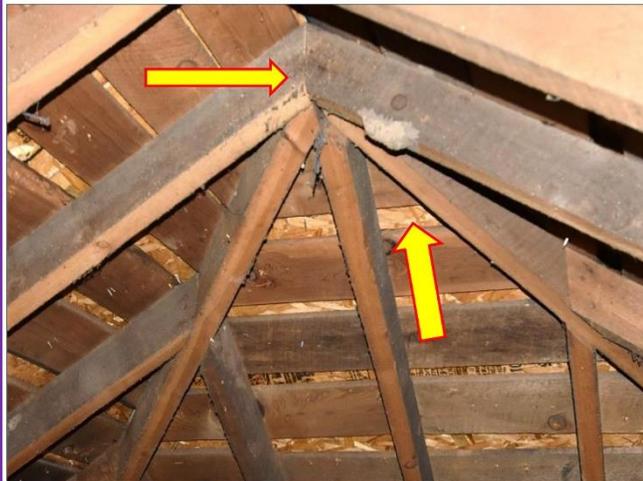
9. Attic has been very well built and OSB panels can be seen in-between rafters whereas the new Propanel roof was fastened to was very well done.

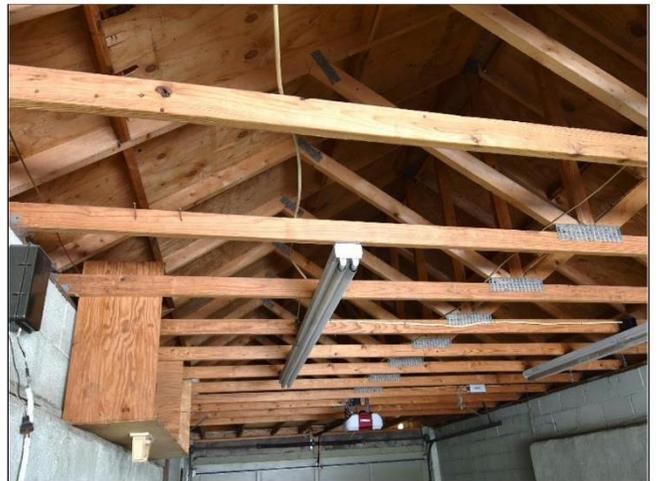
10. Typical engineered trusses built over the Tandem Garage were properly executed and sound.

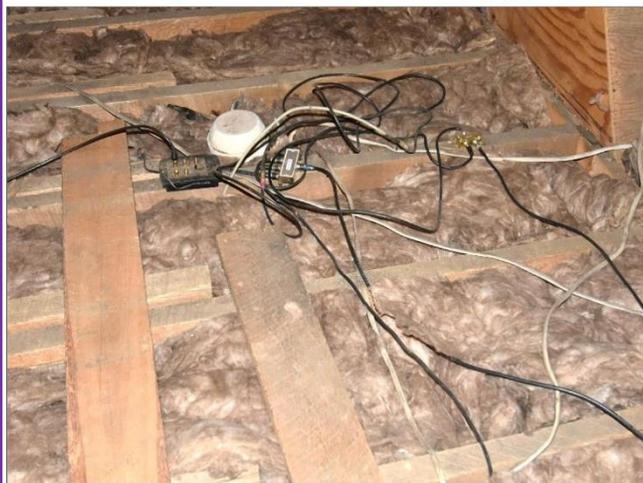
11. Insulation found in-between the rafters in the attic are in Satisfactory Condition. Messy wires will need to be straightened out.

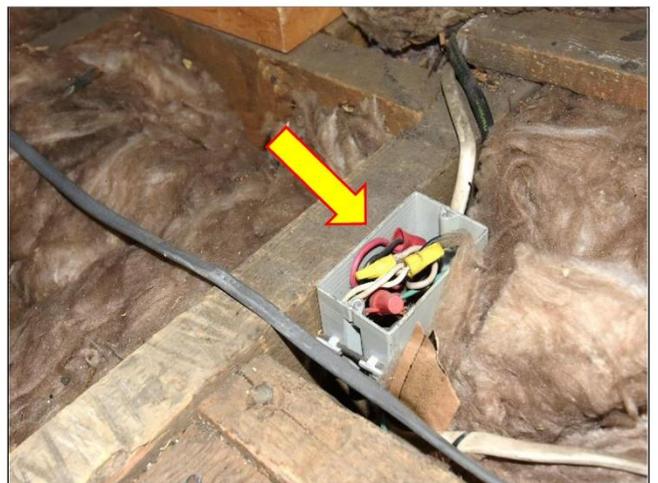
12. Open electrical boxes will need to have cover plates provided to avoid electrical fire hazards.

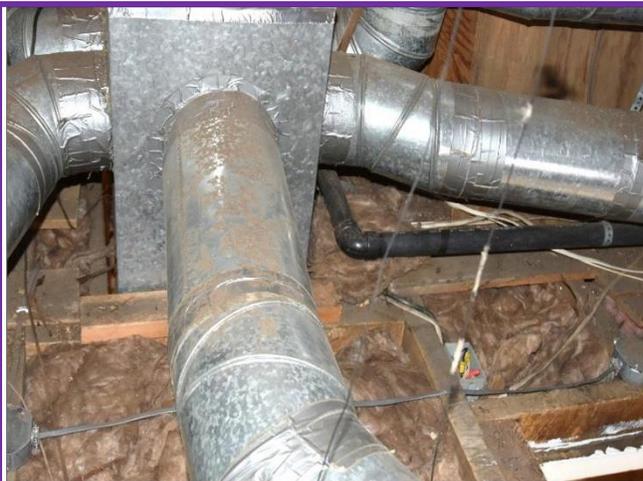
13. Heating ducts found in the Attic have been properly installed and joints were taped with duct and silver tape as per UBC codes.

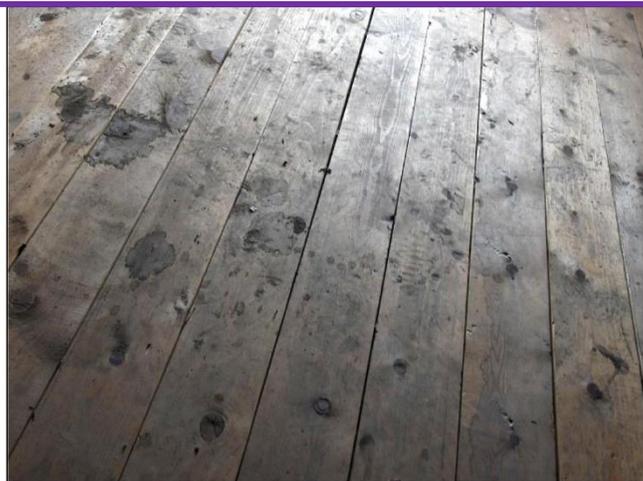
14. Planks laid over joists provide storage flooring in the Attic.

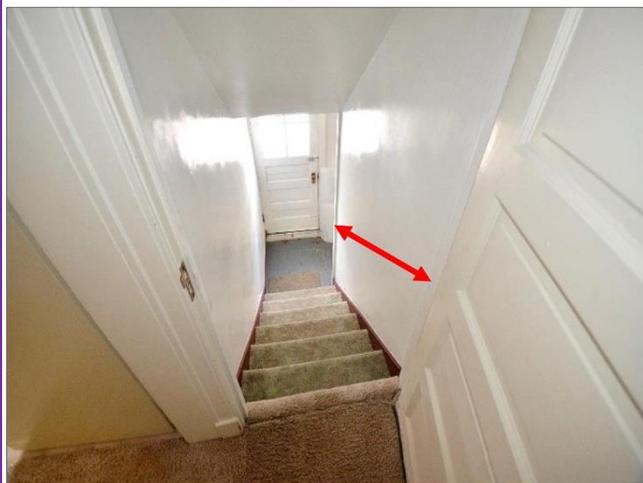
15. Stairs to the Basement will need to have a hand rail installed as per UBC codes.

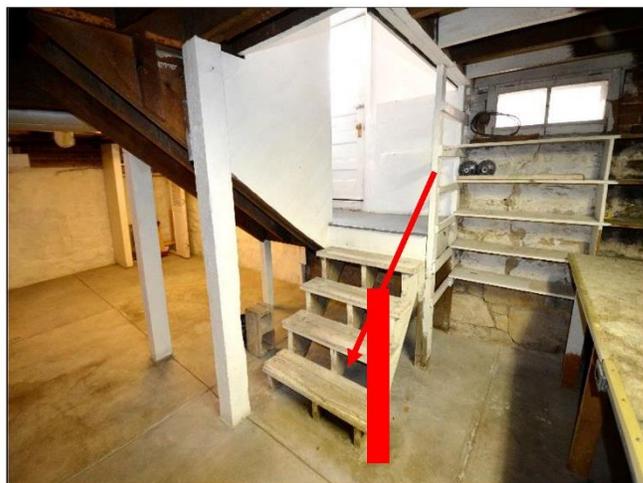
16. Second set of Stairs to the Basement floor will need to have a hand rail and newel post added and installed as per UBC codes

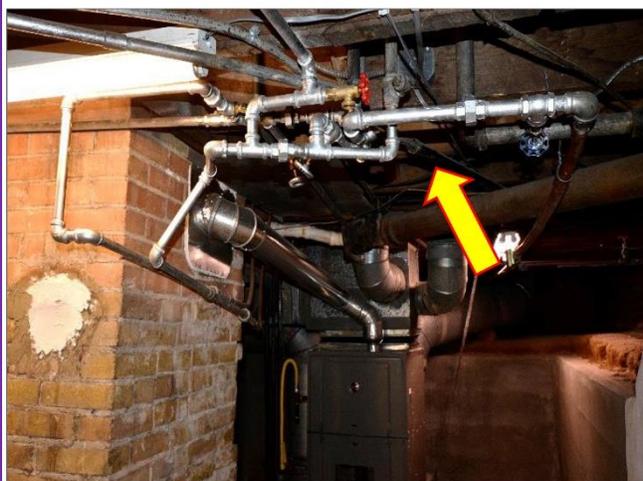
17. Galvanize pipe & valves found on the ceiling in the Basement have been painted with silver paint and are in Satisfactory Condition.

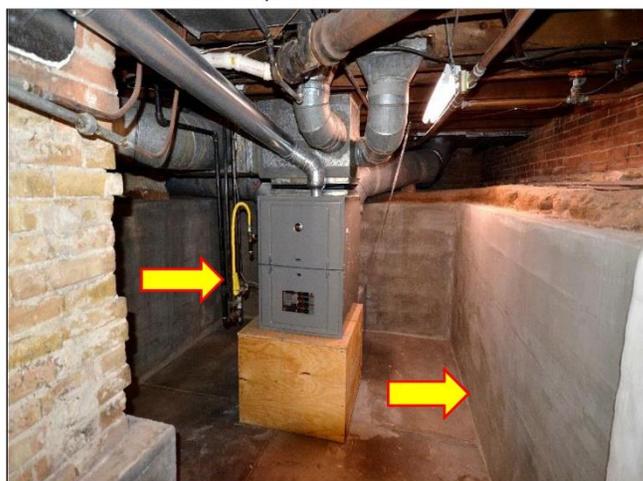
18. Ruud furnace was installed & elevated correctly within a dug-out area in Basement and has been installed with new poured concrete retaining walls.

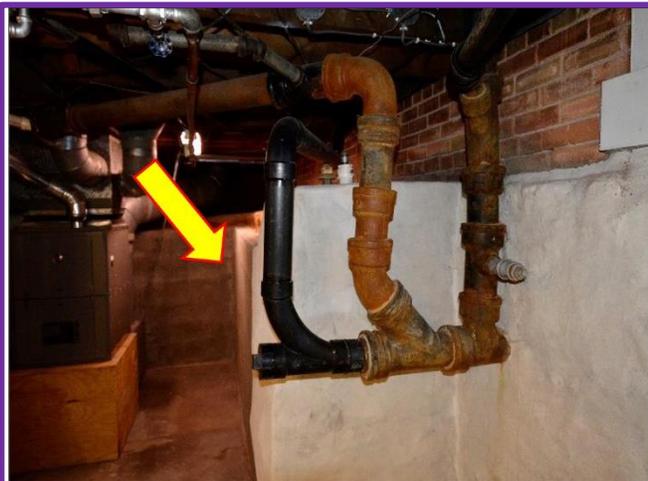
19. Cast Iron Waste pipes in the Basement are routed to the City sewer at the rear of the property's boundary to an utility access alley.

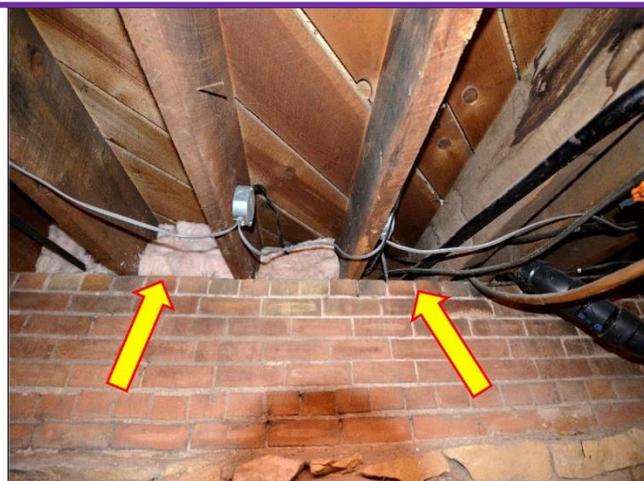
20. Brick stem walls and heavy timber joists are not anchored to the brick opposing any seismic activity that may need remedies by an Engineer.

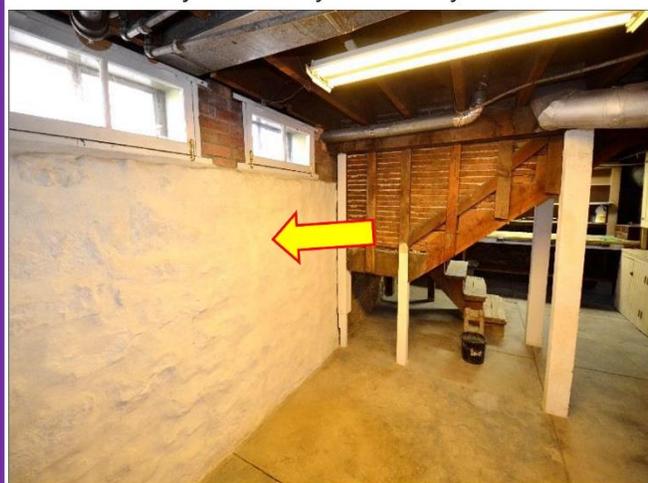
21. Painted rock & mortar stem walls were found in the Basement and installed correctly with poured concrete floors.

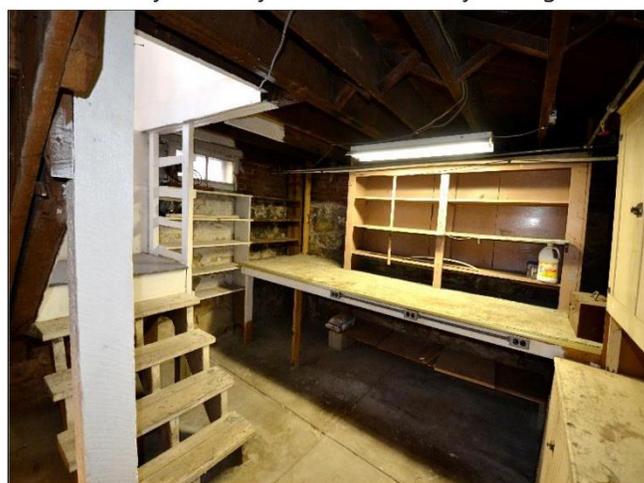
22. Areas of the Basement with normal height ceilings are open and spacious.

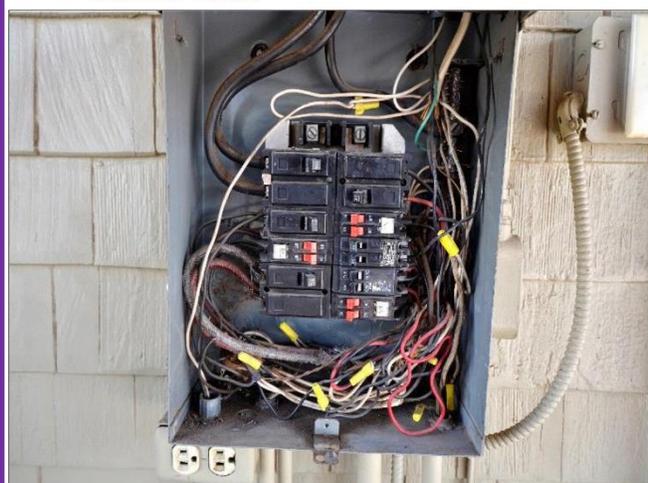
23. Electrical panel found on the back wall will need the services by an electrician.

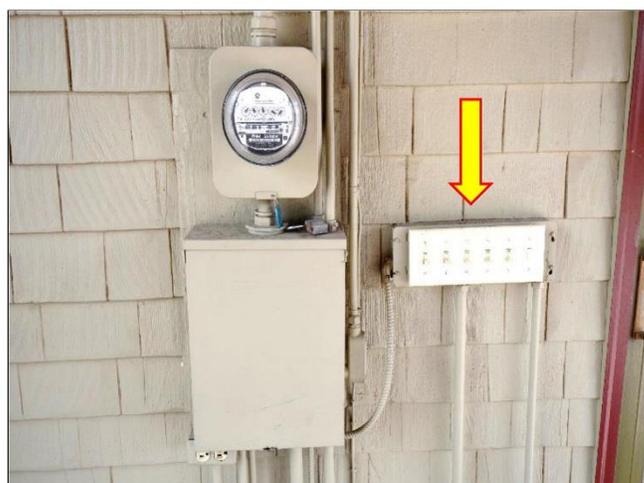
24. Plastic switch cover plate covering 6-gang switches is not correct for exterior uses. Electrician shall provide a correct 6-gang metal cover plate.

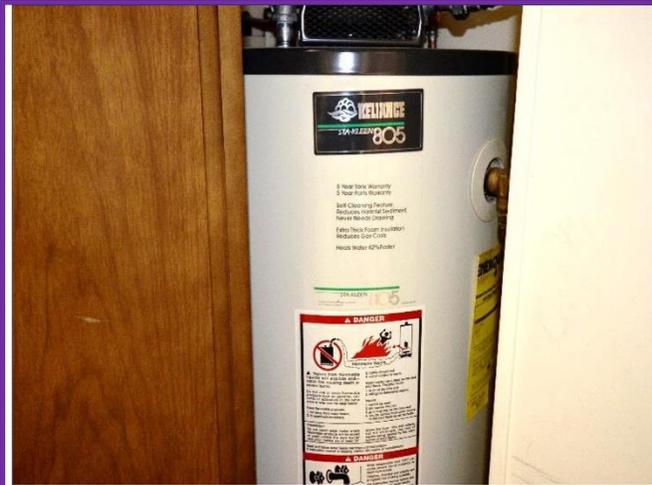
25. Recently installed Reliance H₂O heater found on the First Floor has minimal access and may need attention.

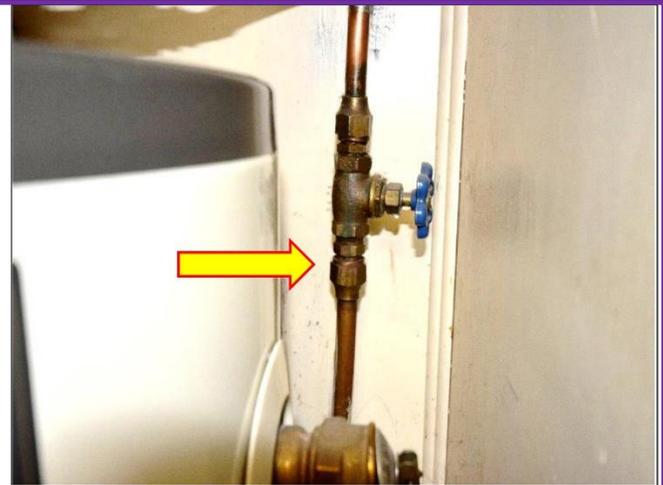
26. Shut-off valve to H₂O heater has a slow leak running to the basement floor and must be fixed to prevent further damages.

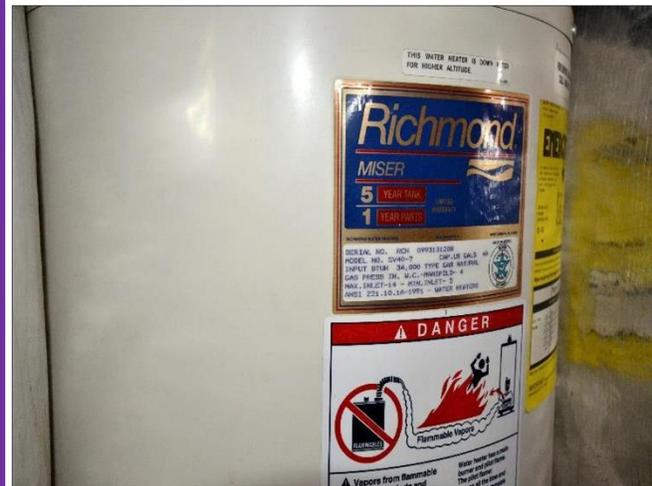
27. Richmond H₂O heater found on the Second Floor has minimal access within a tiny closet with the Ruud furnace. Verify with a Licensed plumber.

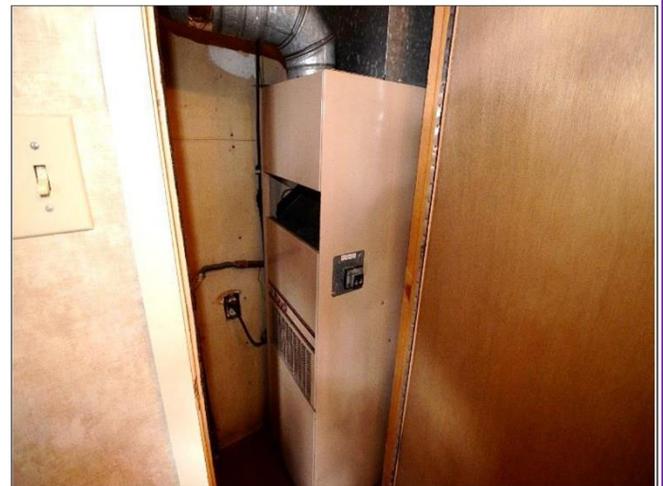
28. Ruud Furnace found on the Second Floor has minimal access within a tiny closet with the Richmond H₂O heater. Verify with a plumber.

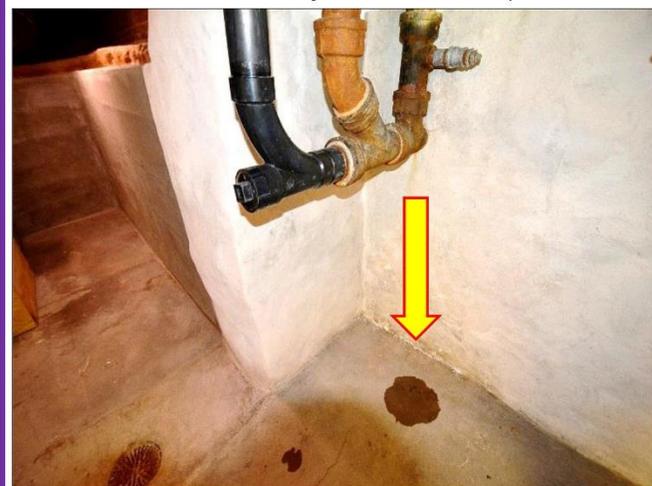
29. Waste piping found in the Basement with recently installed plastic ABS pipes is leaking and this needs to be fixed by a Licensed plumber

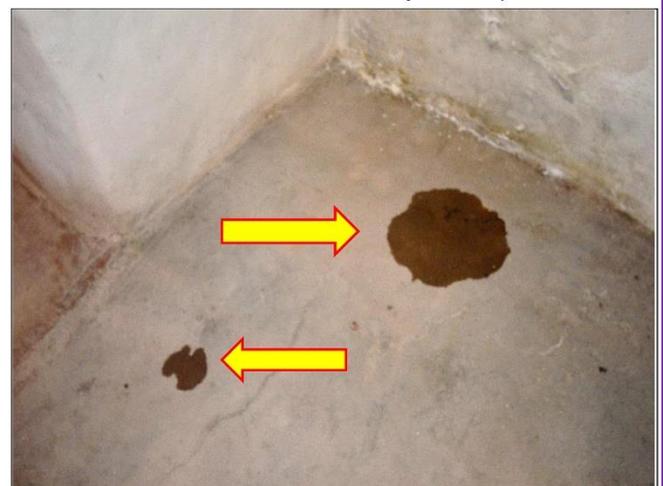
30. Water leaks found on the Basement floor.

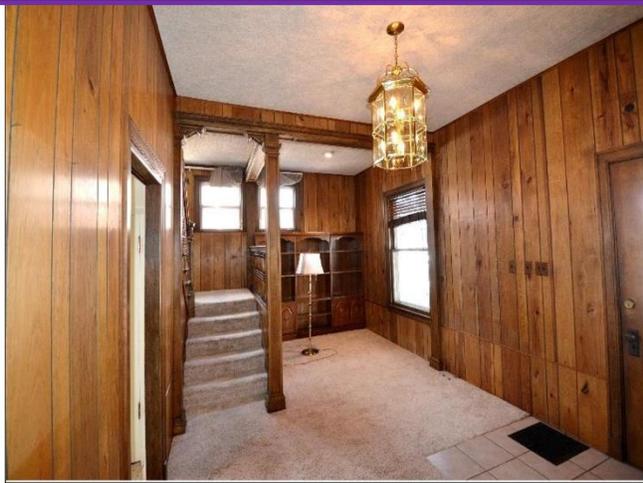
31. Entrance foyer is in Satisfactory Condition with carpet, tile and wood veneer panel walls and a hanging fixture.

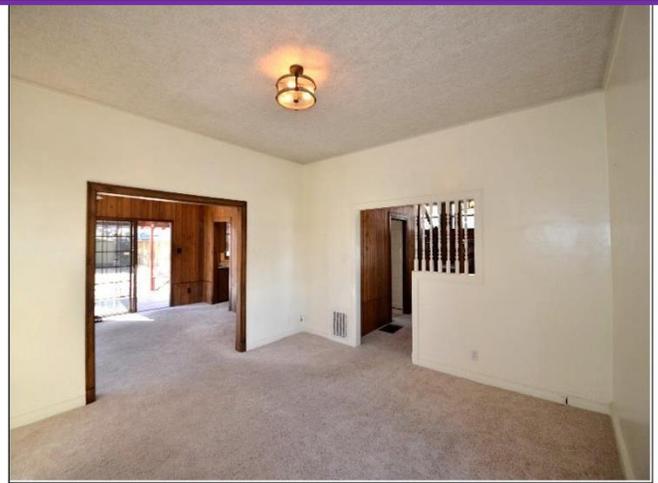
32. Living room with carpet, and painted plaster walls and archways are in Satisfactory Condition.

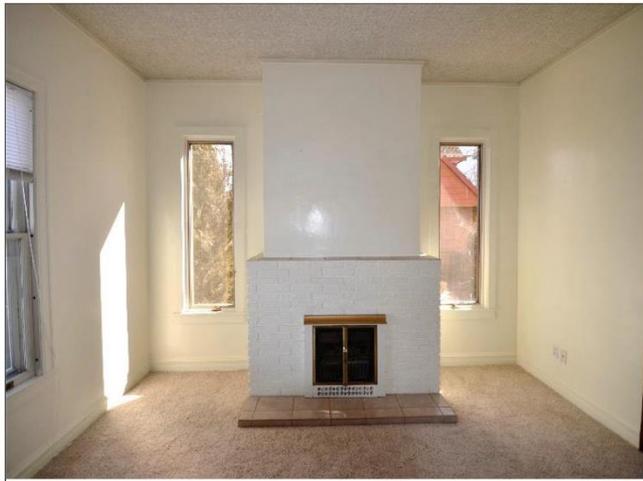
33. Centrally located fireplace in the Living room with equally spaced windows and carpeted floors are in Satisfactory Condition.

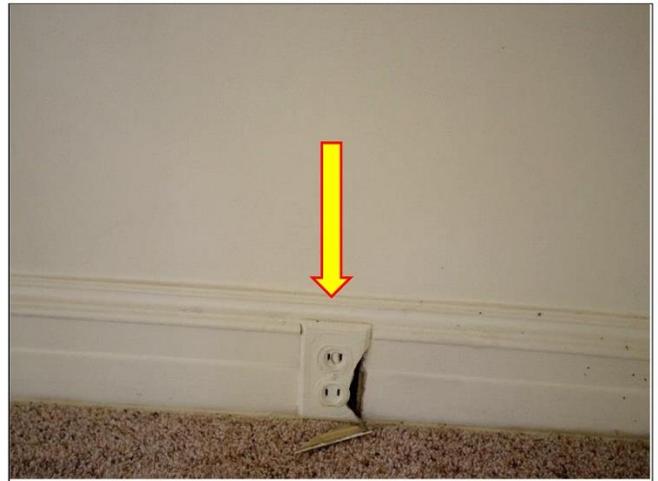
34. Two blade ungrounded receptacle & cover plate is broken and needs to be replaced.

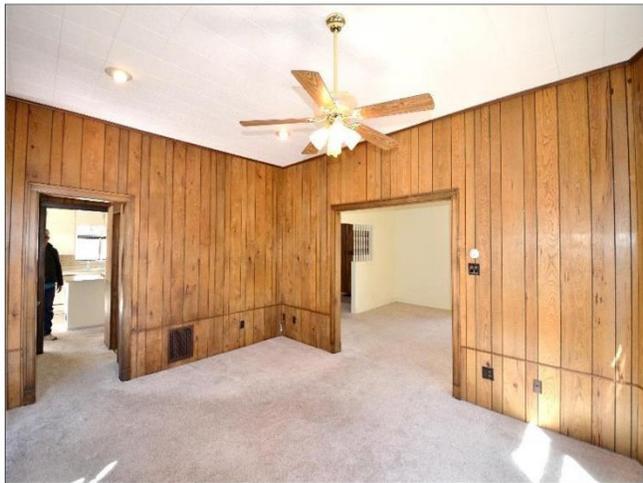
35. 10' high plaster ceilings in the Dining room with wood veneer paneling and carpet floors are in Satisfactory Condition.

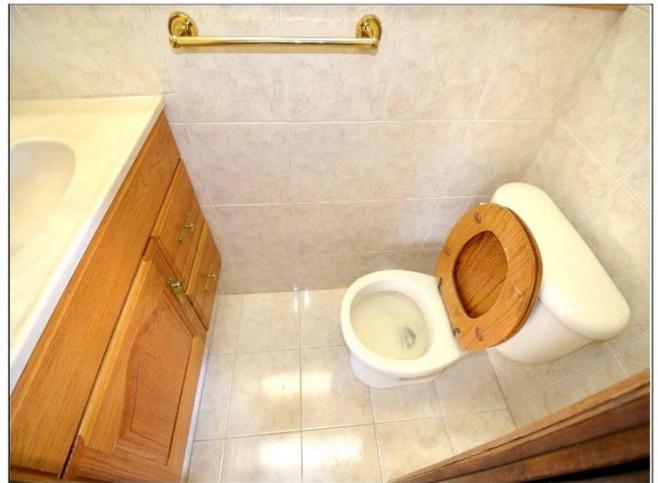
36. Powder room with tile floors and walls off the Kitchen hallway with pocket door is in Satisfactory Condition.

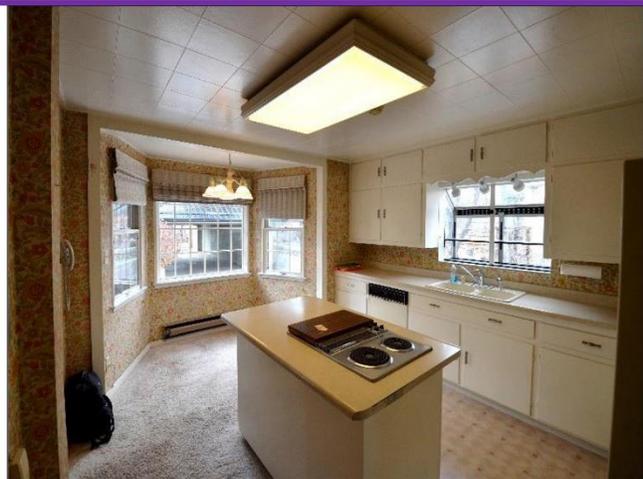
37. Kitchen has an Island with vinyl & carpet flooring and a 10-foot acoustical tile ceiling and are in Satisfactory Condition.

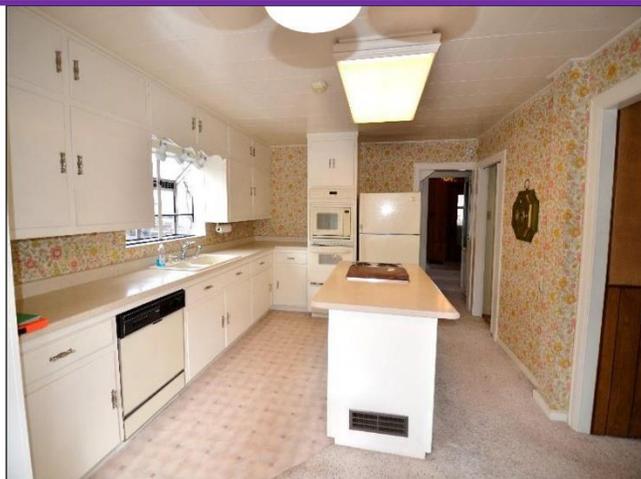
38. Kitchen with Island and older Appliances are in Satisfactory Condition but cannot be verified due to their age.

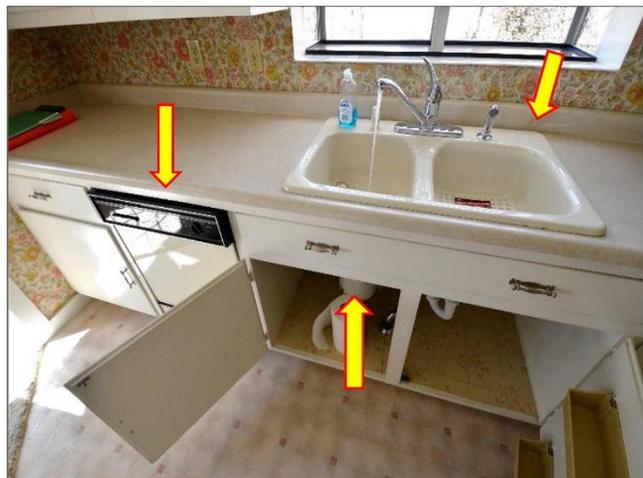
39. An Air Gab is needs on the countertop to provide proper vacuum break on the sink's trap due to having both a dishwasher and waste disposal.

11. An Air Gab needs to be provided on the countertop for Dishwasher/ Disposal to work properly.
12. Provide proper lighting fixtures with 3-way switching over the stairs or wall sconces as per safety codes.

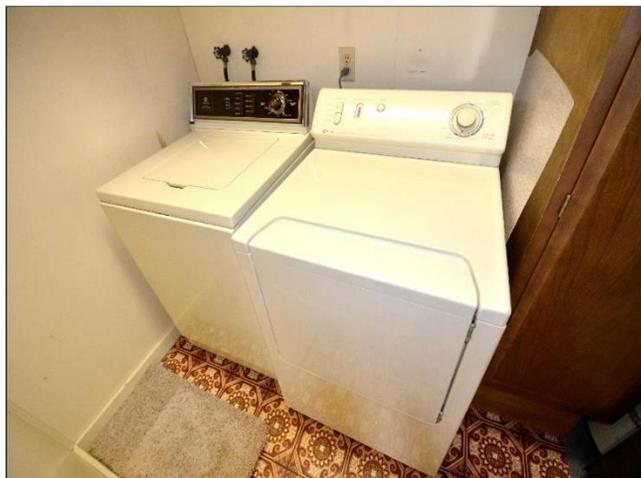
40. Laundry Room with Whirlpool laundry machines are in Satisfactory Condition.

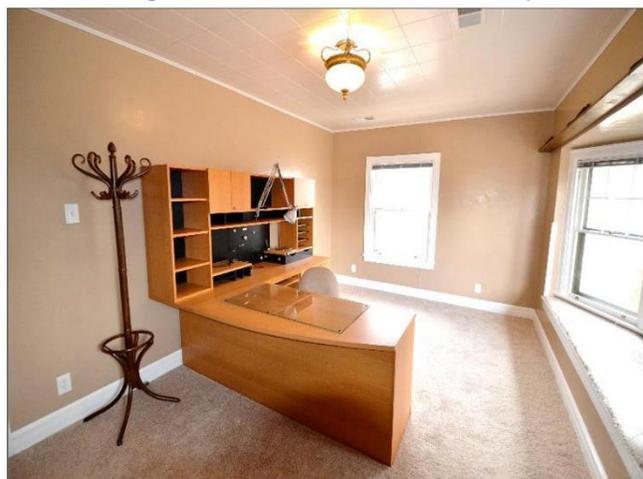
41. Upstairs Bedroom being used as either an office or bedroom and a bow-window is in Satisfactory Condition.

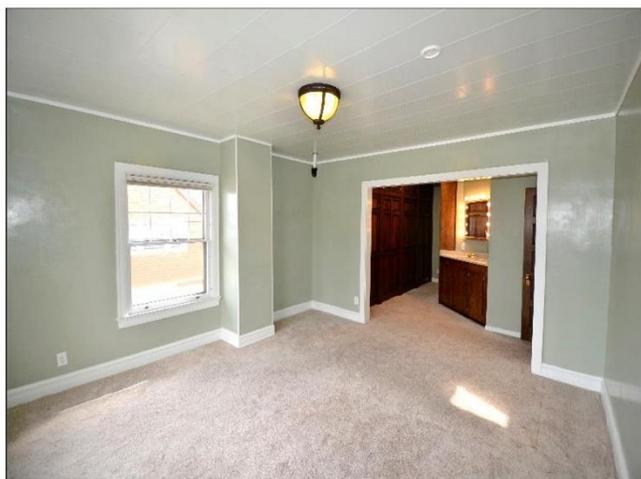
42. Master Bedroom Suite with carpet and painted plaster walls and ceiling and light fixture are in Satisfactory Condition.

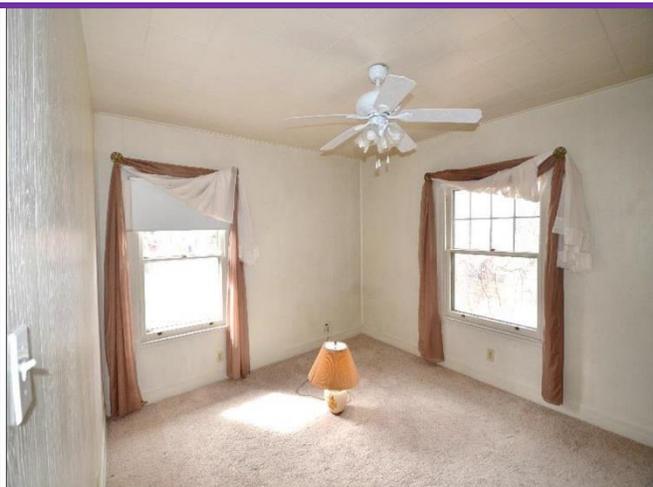
43. Corner Bedroom with the same typical amenities is in Satisfactory Condition.

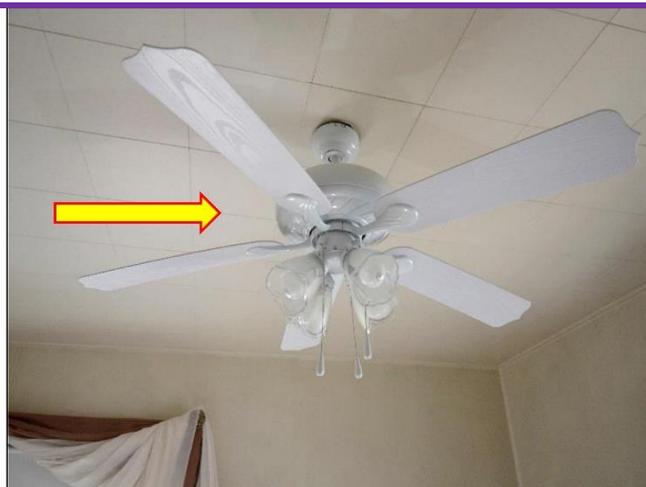
44. Corner Bedroom's fan & light fixture did not work and this needs attention.

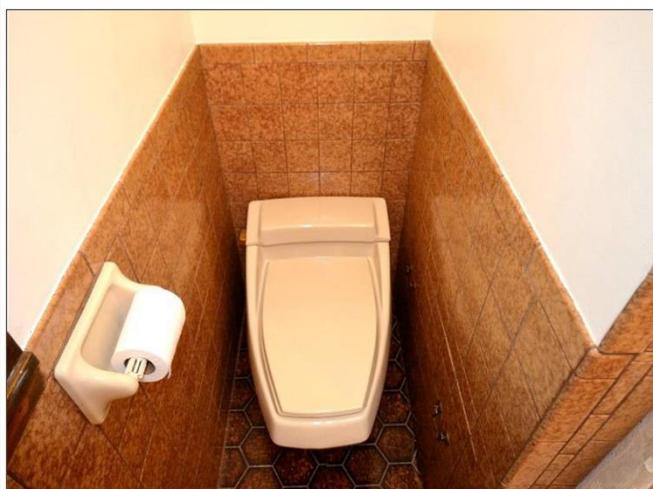
45. Two wall hung Kohler toilets found upstairs are in Satisfactory Condition.

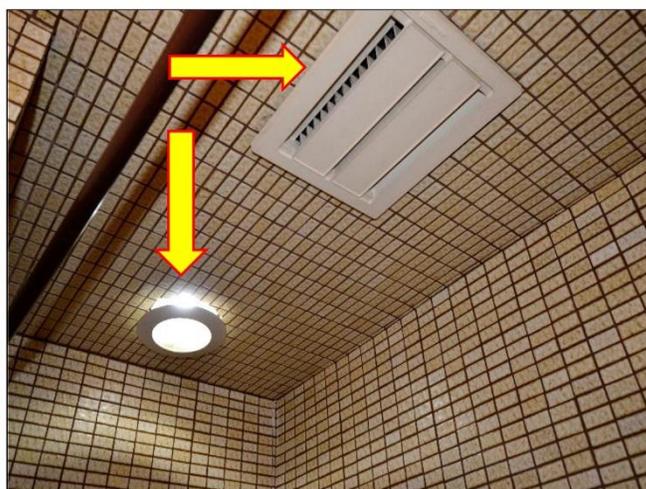
46. Master Suite bathroom's fan is not working and light trim needs to be reset. Tile ceiling and walls are in Satisfactory Condition.

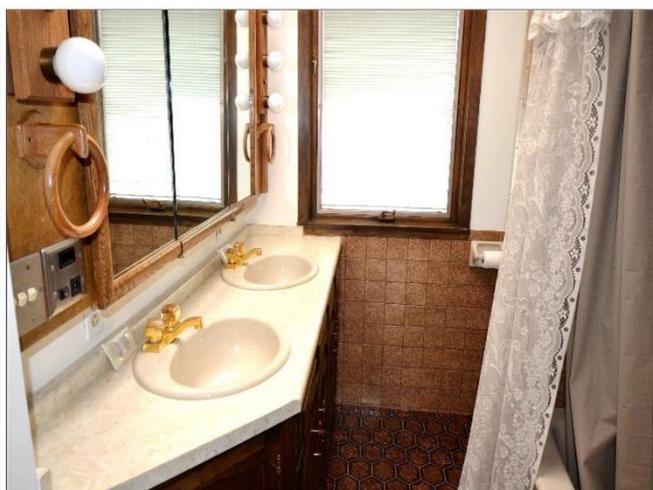
47. Guest Bathroom on the Second floor with two cantilevered countertop and two vanity sinks are in Satisfactory Condition.

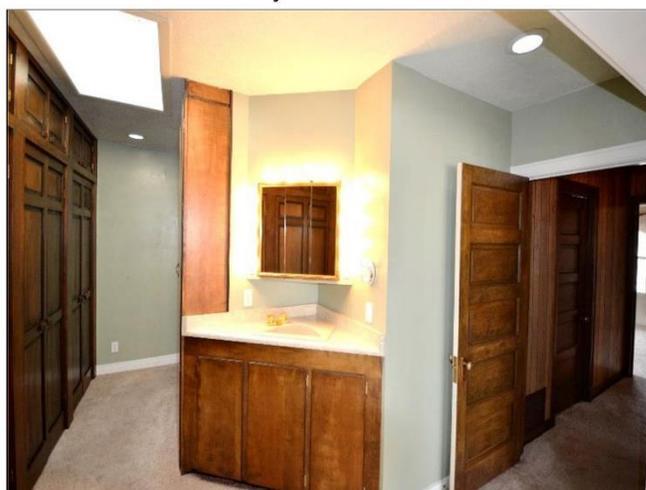
48. Vanity sink found in corner of the Master Suite Bedroom is in Satisfactory Condition.

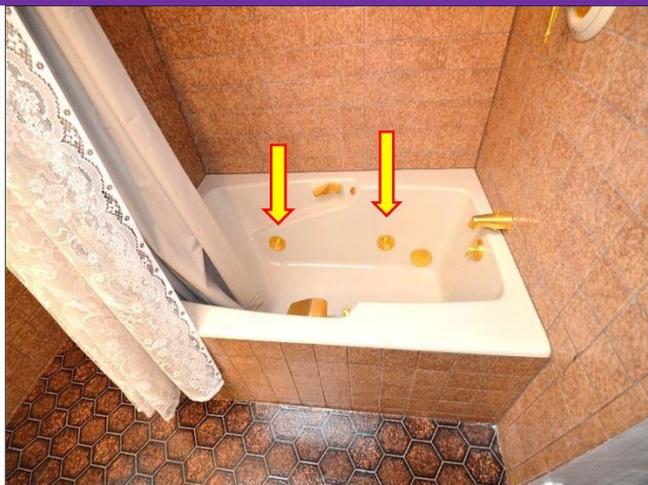
49. Guest Bathroom's bathtub on the Second floor with tile walls and vinyl floor has non-working air jets, "whirlpool" are not working, needs repairing.

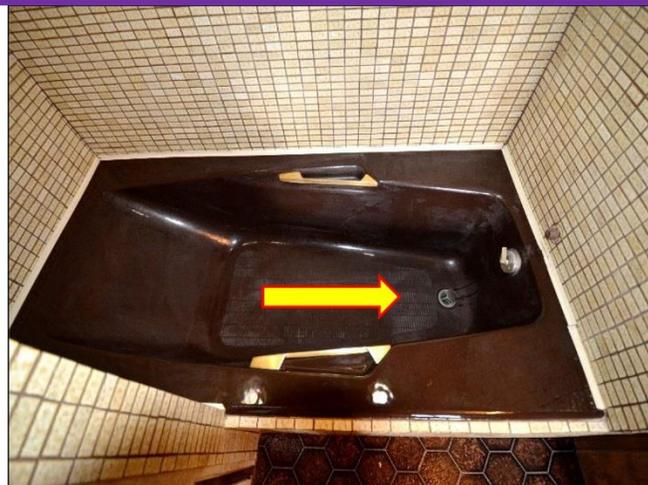
50. Master Suite bathtub is in need of plumbing repairs, especially around the drain stopper.

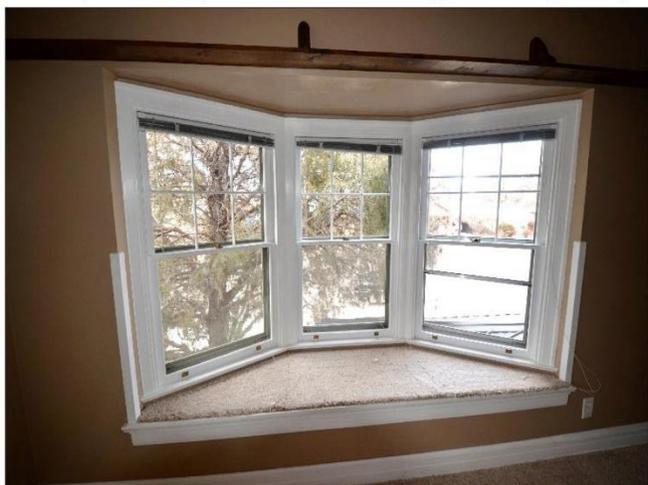
51. Typical bow-window of several are in Satisfactory Condition,

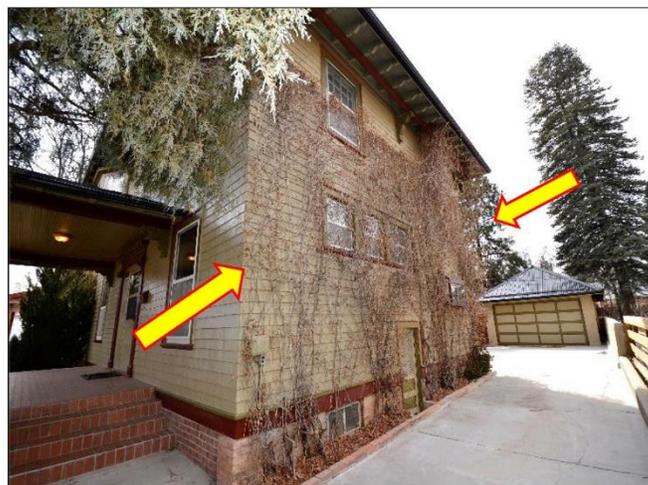
52. Ivy wall will need serious attention to prevent insect activity from boring in the wood shingle walls. Contact a pest control company.

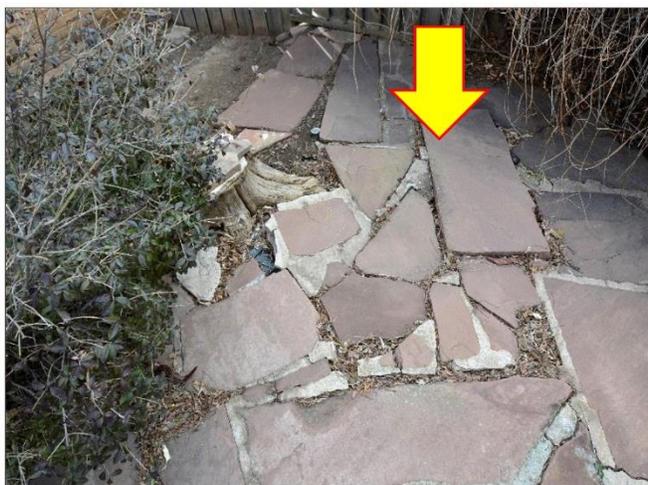
53. Some of the flagstone on the property is dislodged will need resetting and reappointments with the joints and cement grouting.

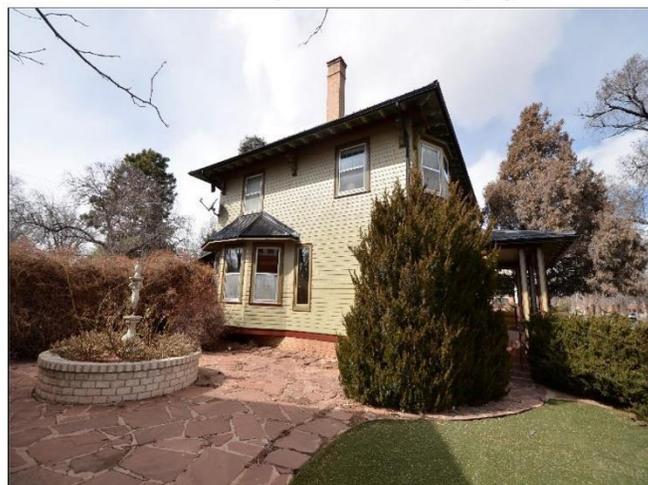
54. Flagstone and fountain at the side yard will need some attention with a landscape company for remedies.

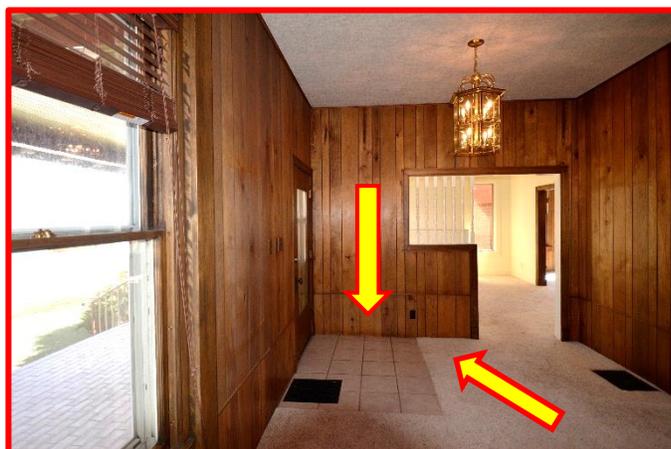
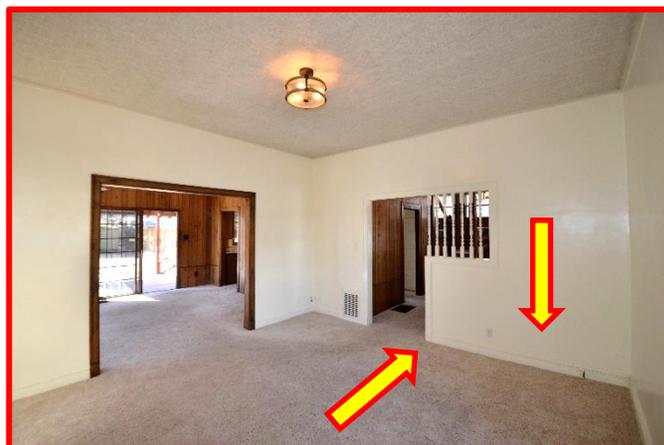
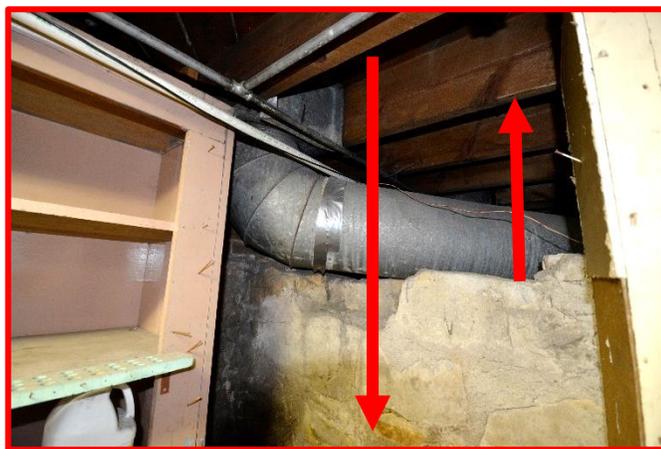
The floor at the Entrance has settled and is sagging about 1-inch at around 36-feet² in area. This was caused by the settlement of the adjacent bearing wall that would need to be leveled and underpinned with shims on the stem wall and footing.

The cut-out through the stem wall in order to install the large duct pipe may have weakened the floor above causing the floor to settle.

The remedy would be to hydraulically raise and level the joists, brace and add posts to support and the floor above.

The cost of this Work would be approximately \$1,500 - \$2,000 and can be done at the same time as the Radon Mitigation Work.
