CONDOMINIUM INSPECTION REPORT

2210 Miguel Chavez Road

Unit 212

Report Number: **10786**

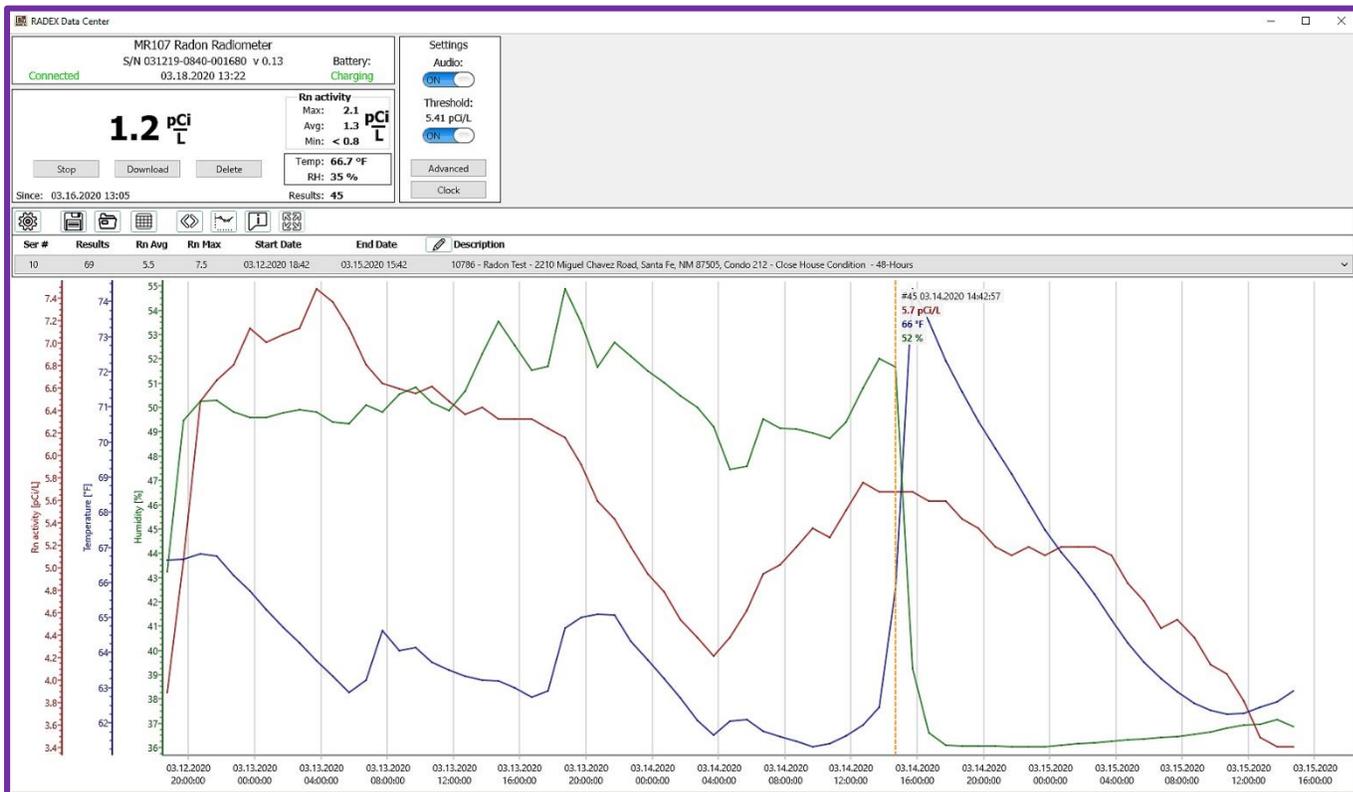
CONDOMINIUM: EPA Radon readings Minimum: **0.89 pCi/L**, Medium: **1.30 pCi/L**, and Expanded: **2.10 pCi/L**. This Condominium Unit has very little Radon exposure, but it should be rechecked within 6-months because the Winter months will generally run higher due to pressure changes within the atmosphere. For further reading: https://www.epa.gov/radon_monoxide

RADEX MR-107 Chart Reading within a 48-hour duration with Close House Conditions' reading on the First Floor with windows closed and centrally located inside the House; taken on 3/16-18/2020.

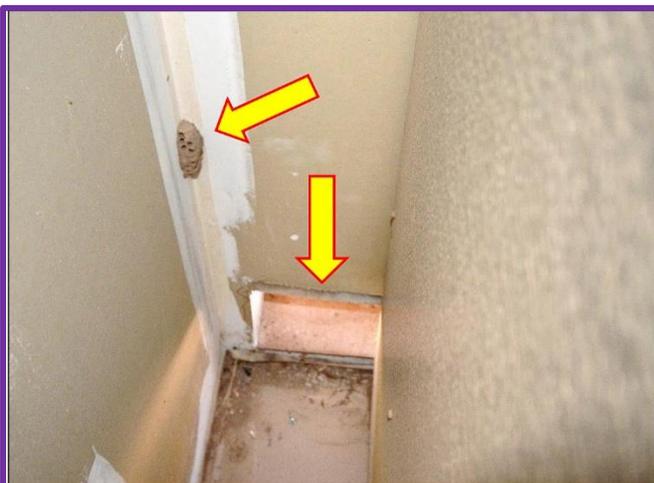
29. **PEST Control:** There was evidence of Wasp nesting inside the Mechanical closet because there was not an insect screen installed on the combustible air vent to prevent Wasps' from entering the closet. Consult with HOA Management for remedies concerning this building flaw on this Condominium Unit as well as other units.

1. Combustible Air Vent to the Mechanical Closet has a problem with the lack of an insect screen to prevent wasp and wasp nests from entering the closet.

2. **Repair:** Seller or HOA to provide an insect screen inside the combustible air vent on the Exterior walls to the Mechanical Closet because Wasps' nesting was found inside the closet.

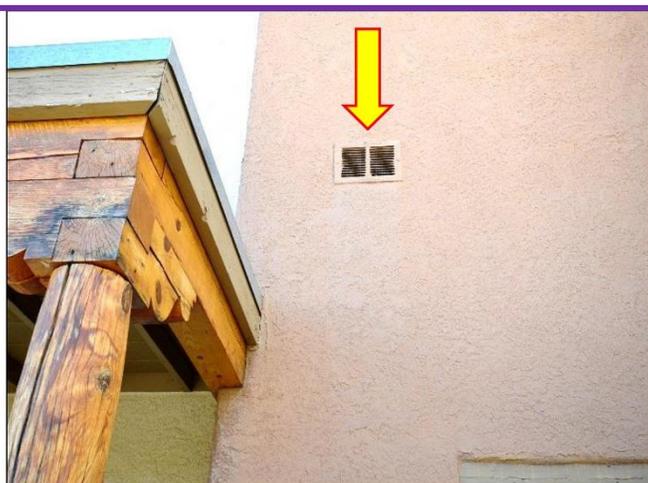
2. Exterior view of the combustable air vent that is accessible form the outside wall above the Portal.

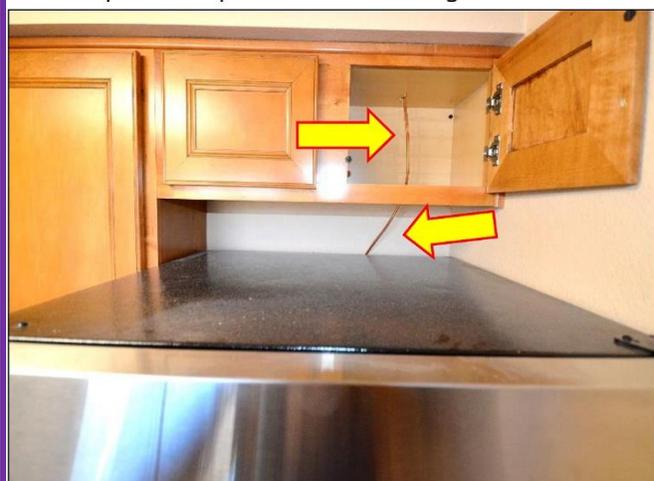
3. 1/4" copper tubing from the Mechanical closet routed through the cabinet and behind the Refrigerator for the icemaker to operate.

7. **REPLACED:** to Replace Mansfield Toilet seat on the Hallway Bathroom.
8. **PENDING:** to complete the 1/4" copper supply tubing & hook-up with valve to the refrigerator's ice maker.

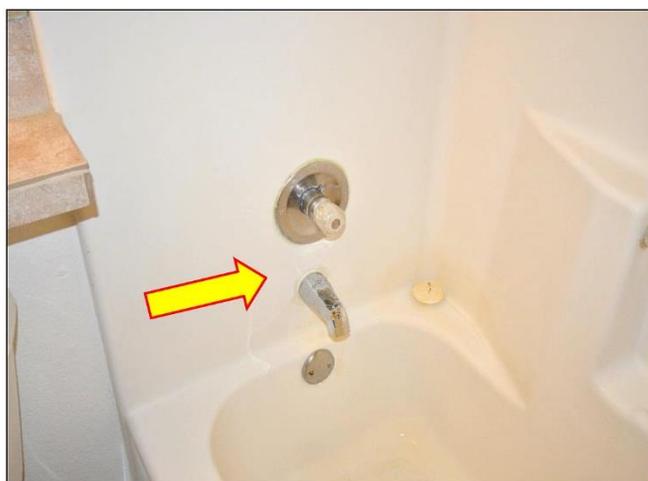
4. Delta Faucet and diverter valve was professionally replaced and is like a brand-new installation.

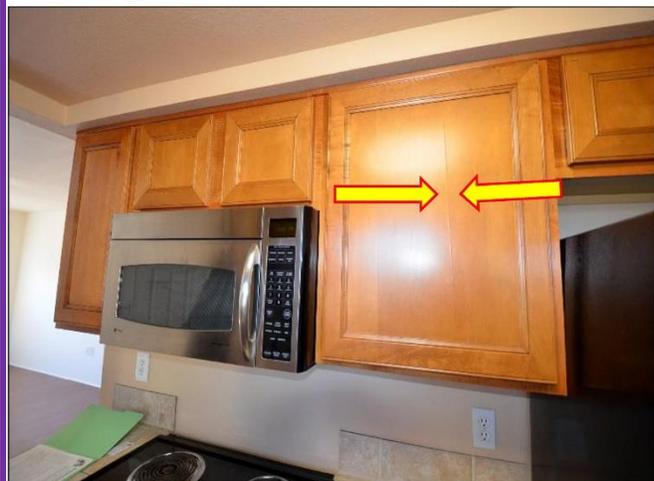
5. Kitchen Cabinet door is blistered and will need to be refinished with proper cabinet making detailing.

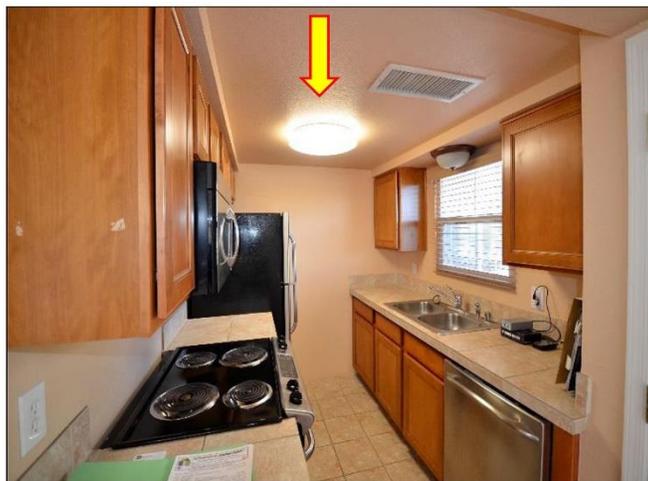
6. Overall, the Kitchen's improvements were carried out professionally and the center light fixture was exchanged with a superior light fixture.
