Commercial Inspection Report

810 Calle Saragosa
Santa Fe, NM 87505

Inspection Date: 1/14/20

Inspection No: 10723

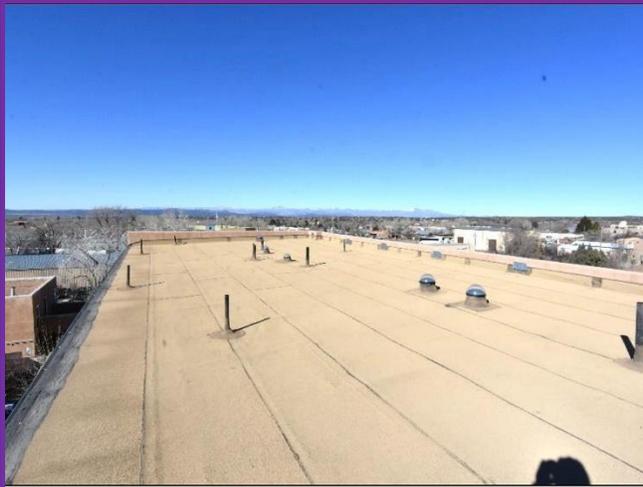
1. Torch-down roof membrane is in **Good Condition** and was recently re-roofed, but the edging details will need more work.

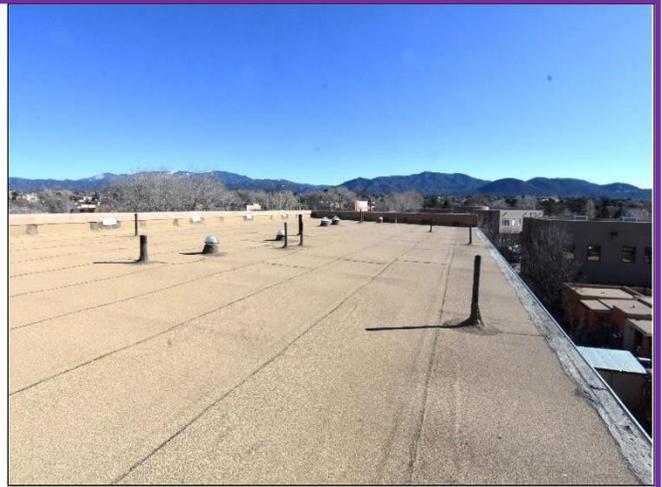
2. Another view of the Torch-down roof showing the drainage edge that will need more repairs and to be redressed.

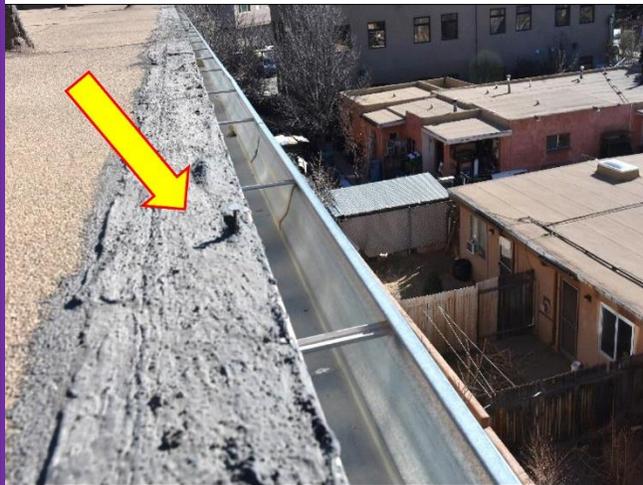
- 9.2.1 Parapets on the South drainage ramp is in **Poor Condition** with roofing nails sticking up and will need to be reset.
- 9.2.2 On the Northside of the Building on the West adjoining neighbor's building, there is a serious breach on top the roof at the first story overhang that will need to be repaired.

3. Drainage edge to Gutter is in rough shape with nails sticking up and will need serious repairs.

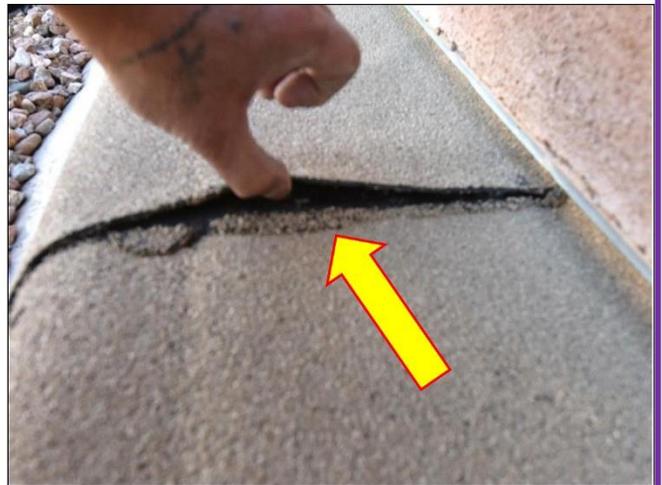
4. Neighbor's building is showing some Torch-down failures on an overlap that could impact the Inspected "810" Building.

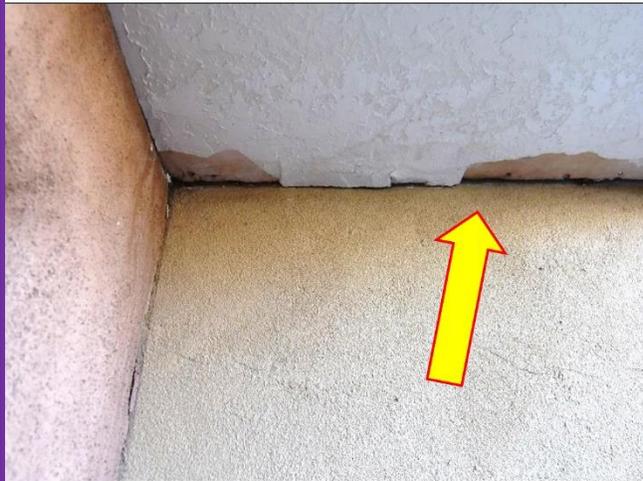
5. Eave soffit on the West end of the Building that is badly leaking and will need a major repair.

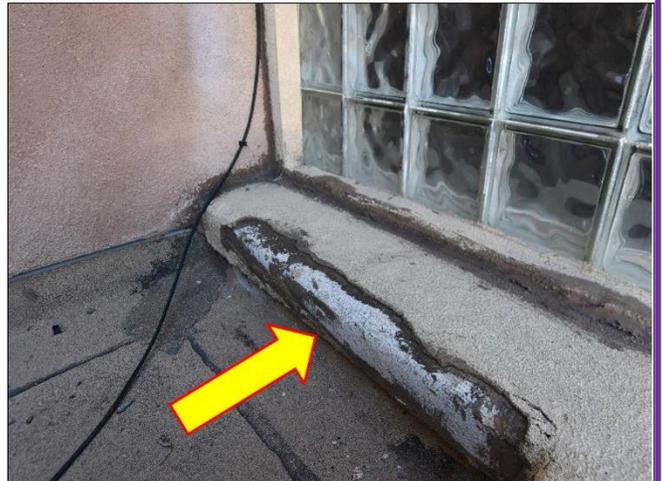
6. On top of the First story roof deck on the West-side showing damages that are causing leaks underneath the eave and soffit.

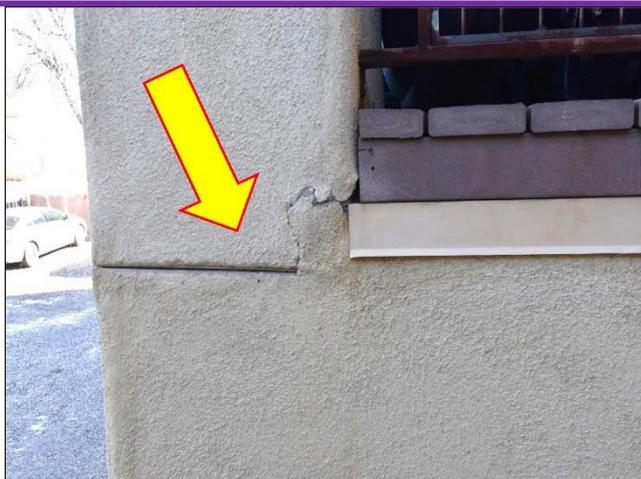
7. Flashing failures on all of the Balcony decks that will need to be repaired and re-stucco.

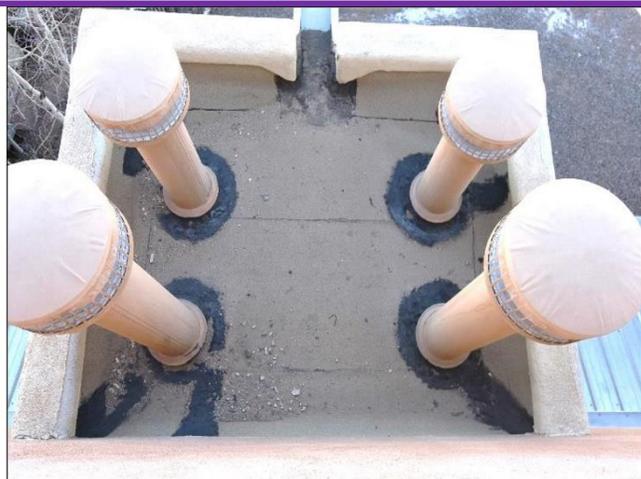
8. Upper Mechanical shafts rooftops that are in **Good Condition** with roof jacks and drainage to canale.

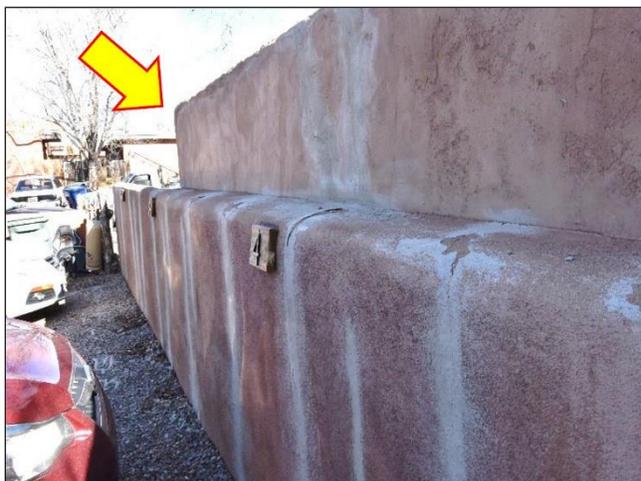
9. Parking lot wall that was not repaired correctly and will need patching and re-stucco with color coat.

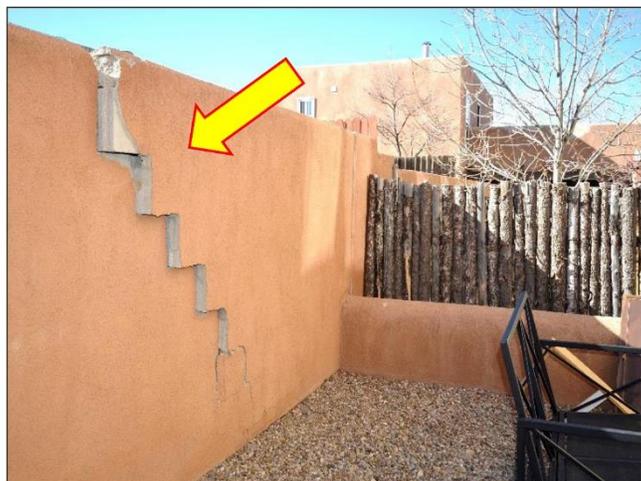
10. Apartment Two's Patio wall on backyard that is in failure.

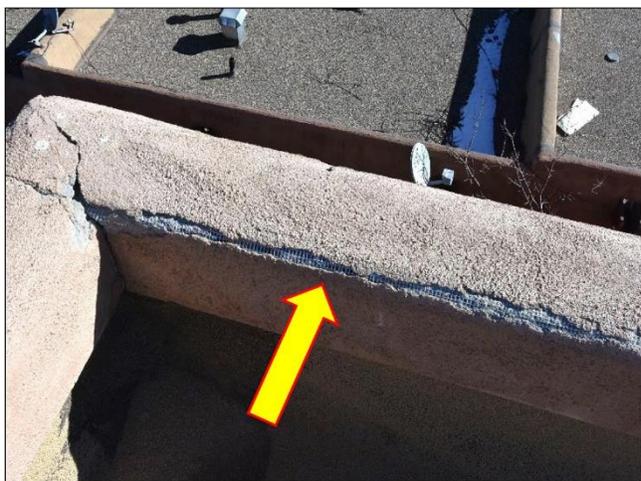
11. Parapets circumventing the entire roof will need to be parch and wrapped with **Flexyl** Standards.

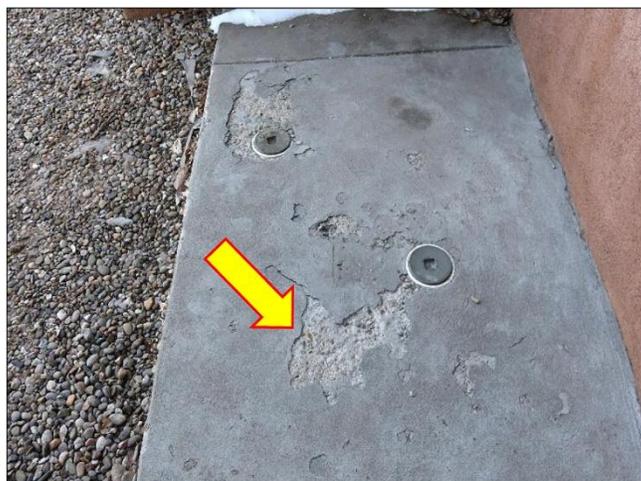
12. Typical concrete sidewalk that will need to be resurfaced due to spading and erosion.

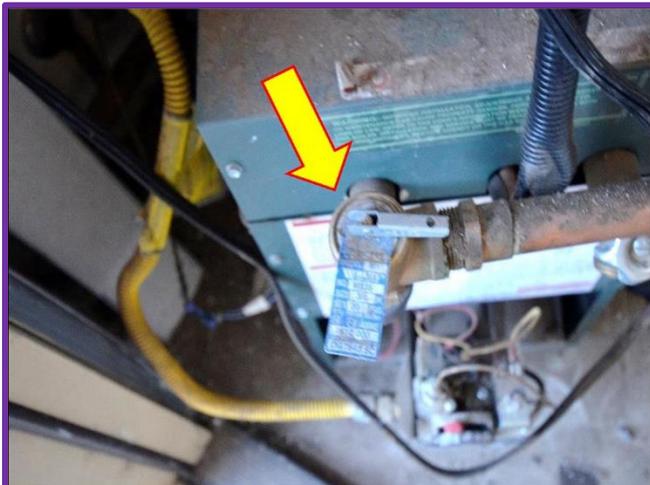
13. Two T&P valves were found to be frozen inside Apartments One and Three.

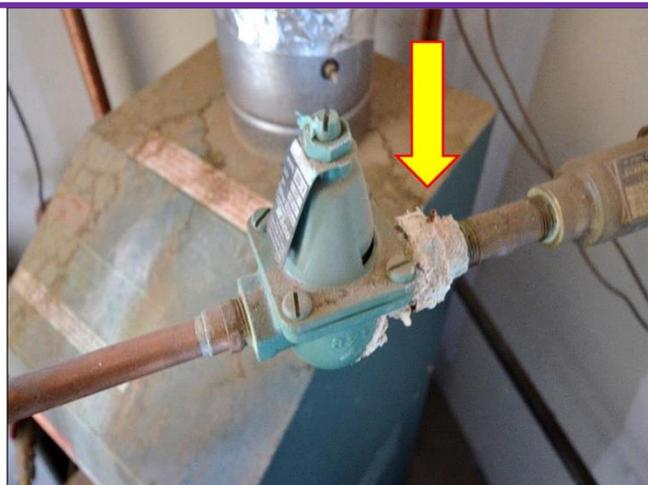
14. Calcium build-up on the pipe fittings found in most of the Mechanical closets that will need to be cleaned with solvents.

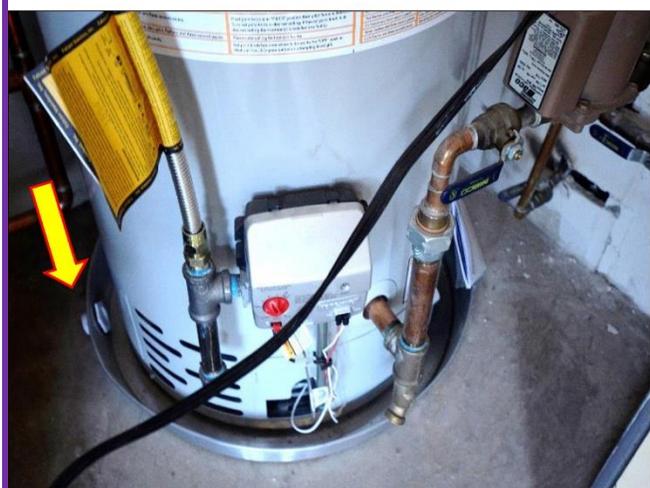
15. Five of the safety pans under the H₂O heaters will need a drainpipe and routed to an outside wall for proper drainage.

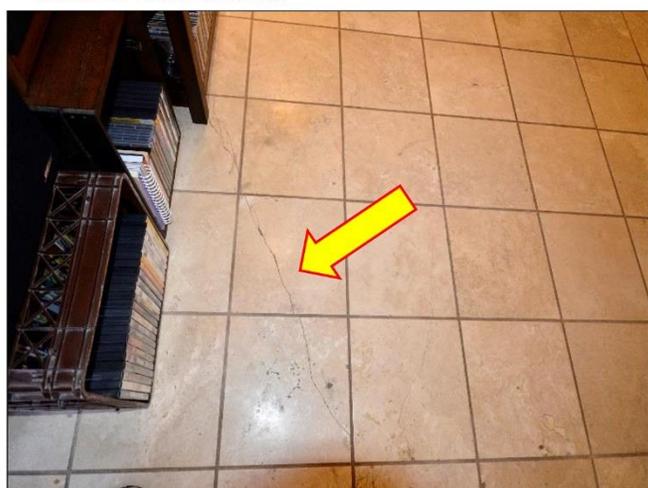
16. First floor level showing many cracks that will need profession attention to remove and replace with a tile isolation membrane.

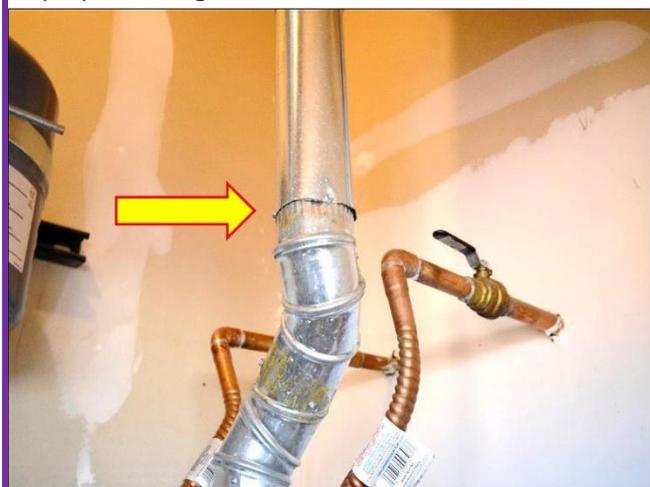
17. Exhaust connection that will need to be silvered taped to seal properly.

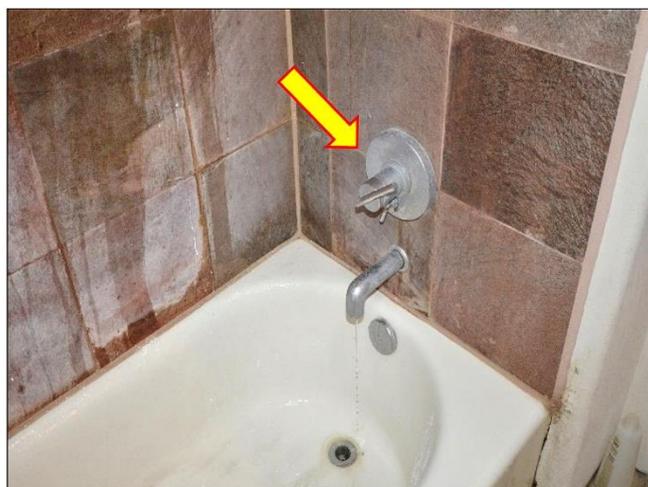
18. Three of the bathtub and shower valves were in **Poor Condition** and the diverter valves were not properly working and will need to be replaced.

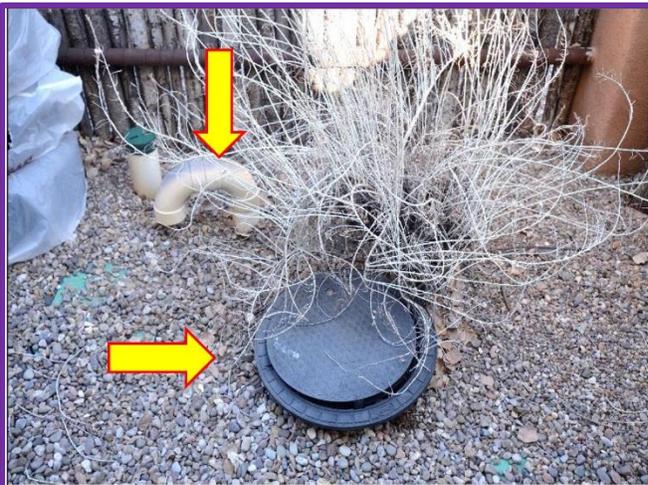
19. Storm drain equipment found on Apartment One's Patio will need to be verified and certified by an Engineer.

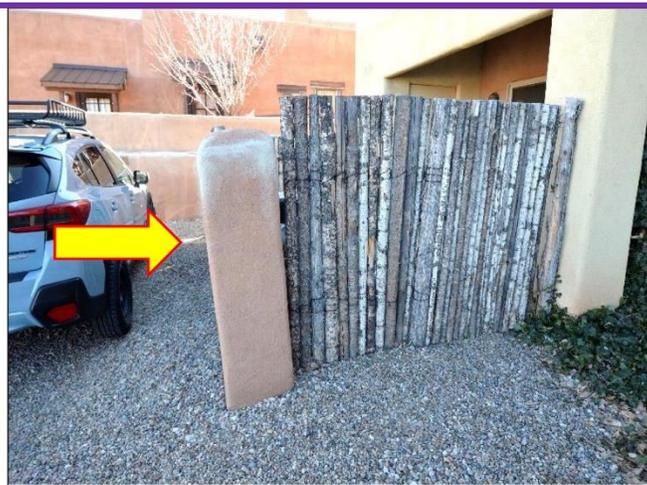
20. CMU block column is badly leaning on Apartment One's Patio with the possibility that the cause is due to Storm drainage equipment.

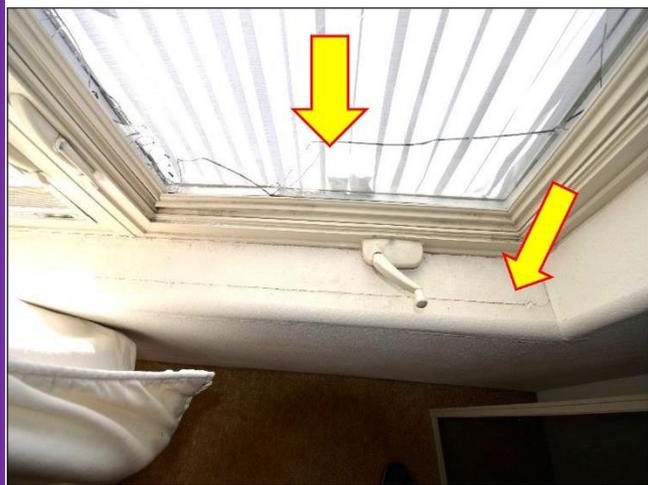
21. Bedroom window on Apartment Three is broken and will need to be replaced and observe that all the windowsill were cracked and will need repairing.

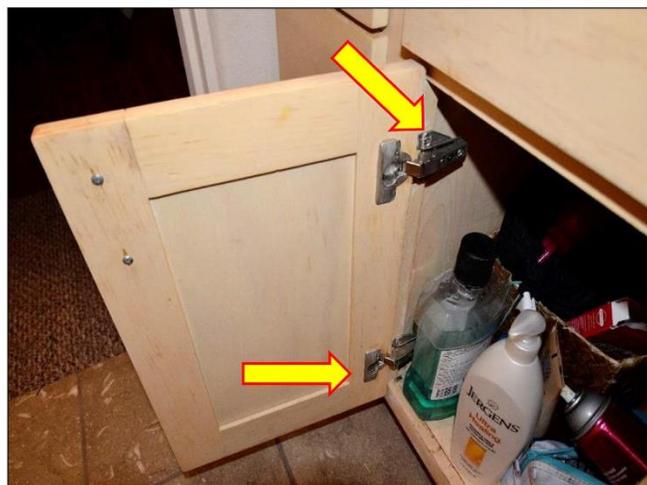
22. All cabinet doors on the Kitchen and Vanity cabinets will need to have the hinges exchanged for the proper euro stiles type of hinges.

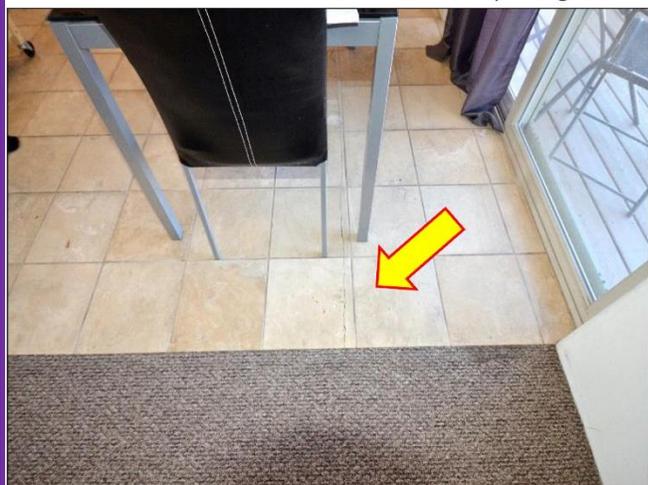
23. Second floor level is also showing cracking on the ceramic tile floors and will need to be removed and replaced with a tile isolation membrane.

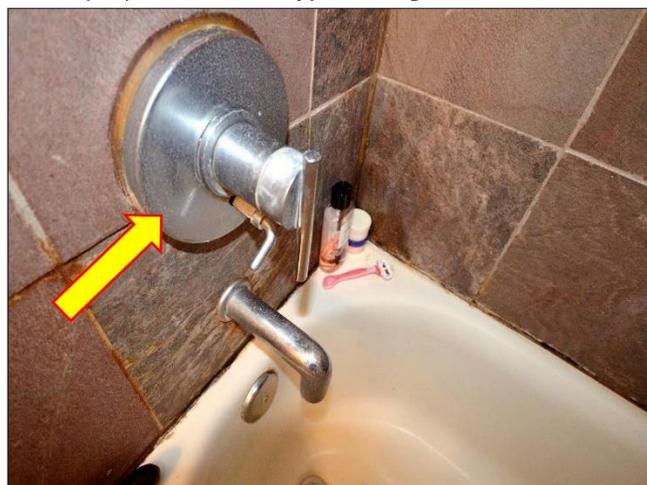
24. Three of the bathtub and shower valves were in **Poor Condition** and the surround tile walls will need to be cleaned and the caulked to properly seal.

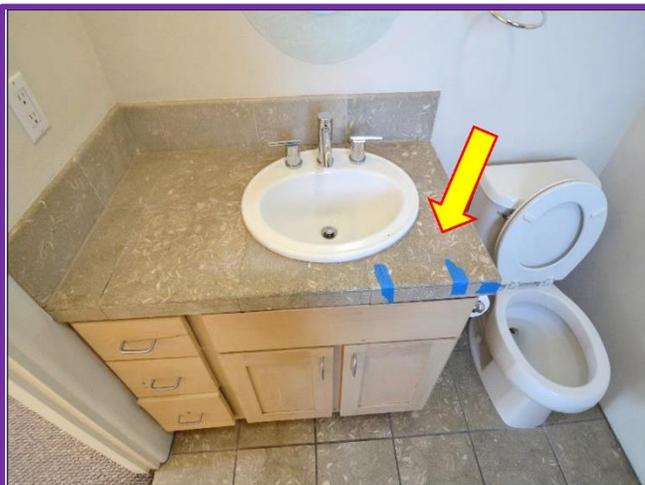
25. Make sure all tile on the countertops are secured.

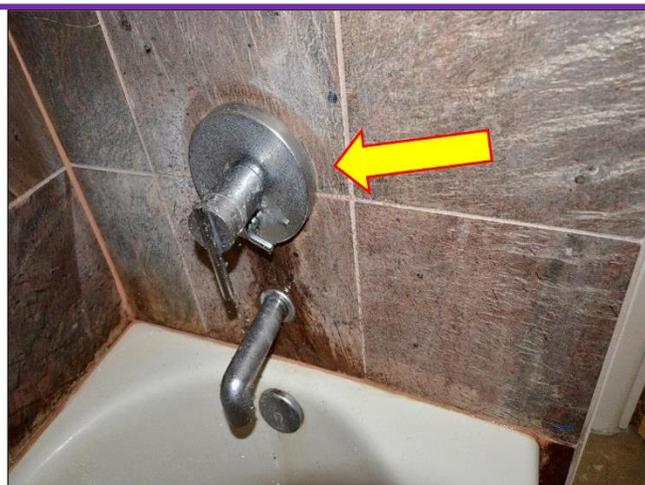
26. Another example of a bathtub and shower valve that has failed.

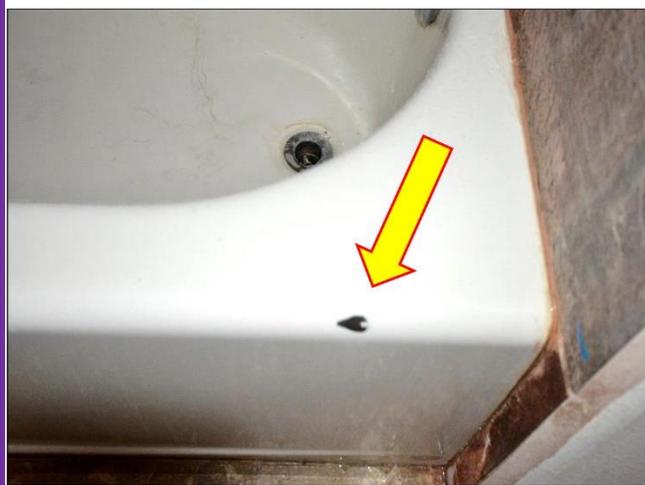
27. One chip sound on Apartment Three that will need to be repaired.

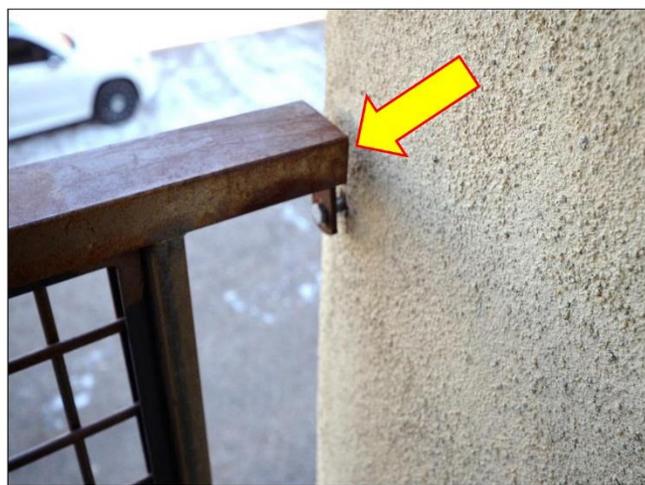
28. Most of the Balcony railings will need to be secured to the wall with solid steel spacers.

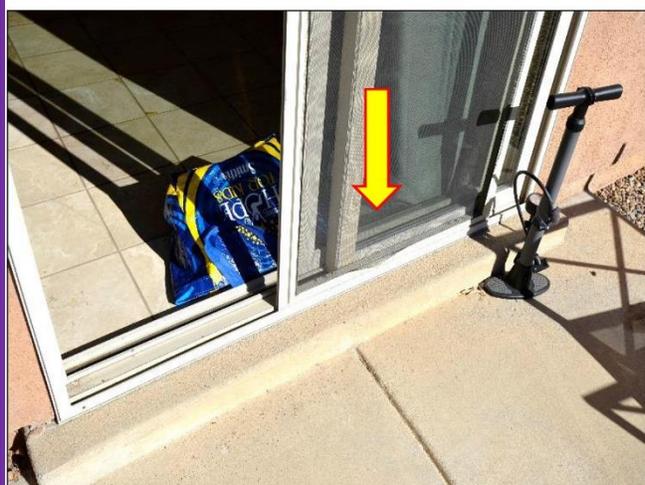
29. Several screens were damaged and will need to be rescreened.

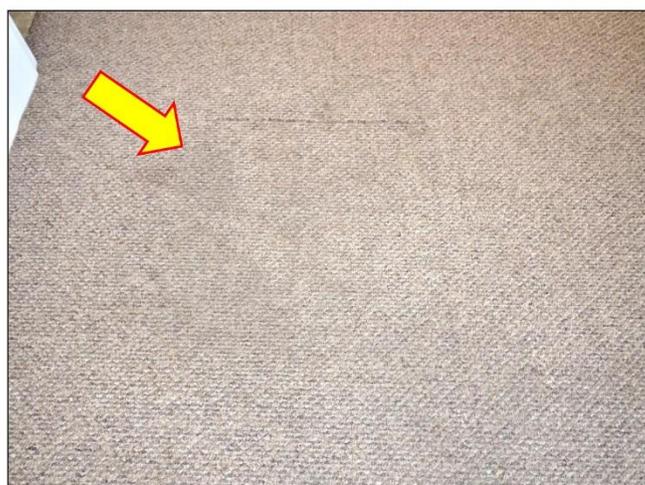
30. Carpet on Apartment Four is frayed and will need to be replaced.
